# Morphological and Sedimentological Impacts of Hurricane Ivan and Immediate Poststorm Beach Recovery along the Northwestern Florida Barrier-Island Coasts

Ping Wang, James H. Kirby, Joseph D. Haber, Mark H. Horwitz, Paul O. Knorr, and Jennifer R. Krock

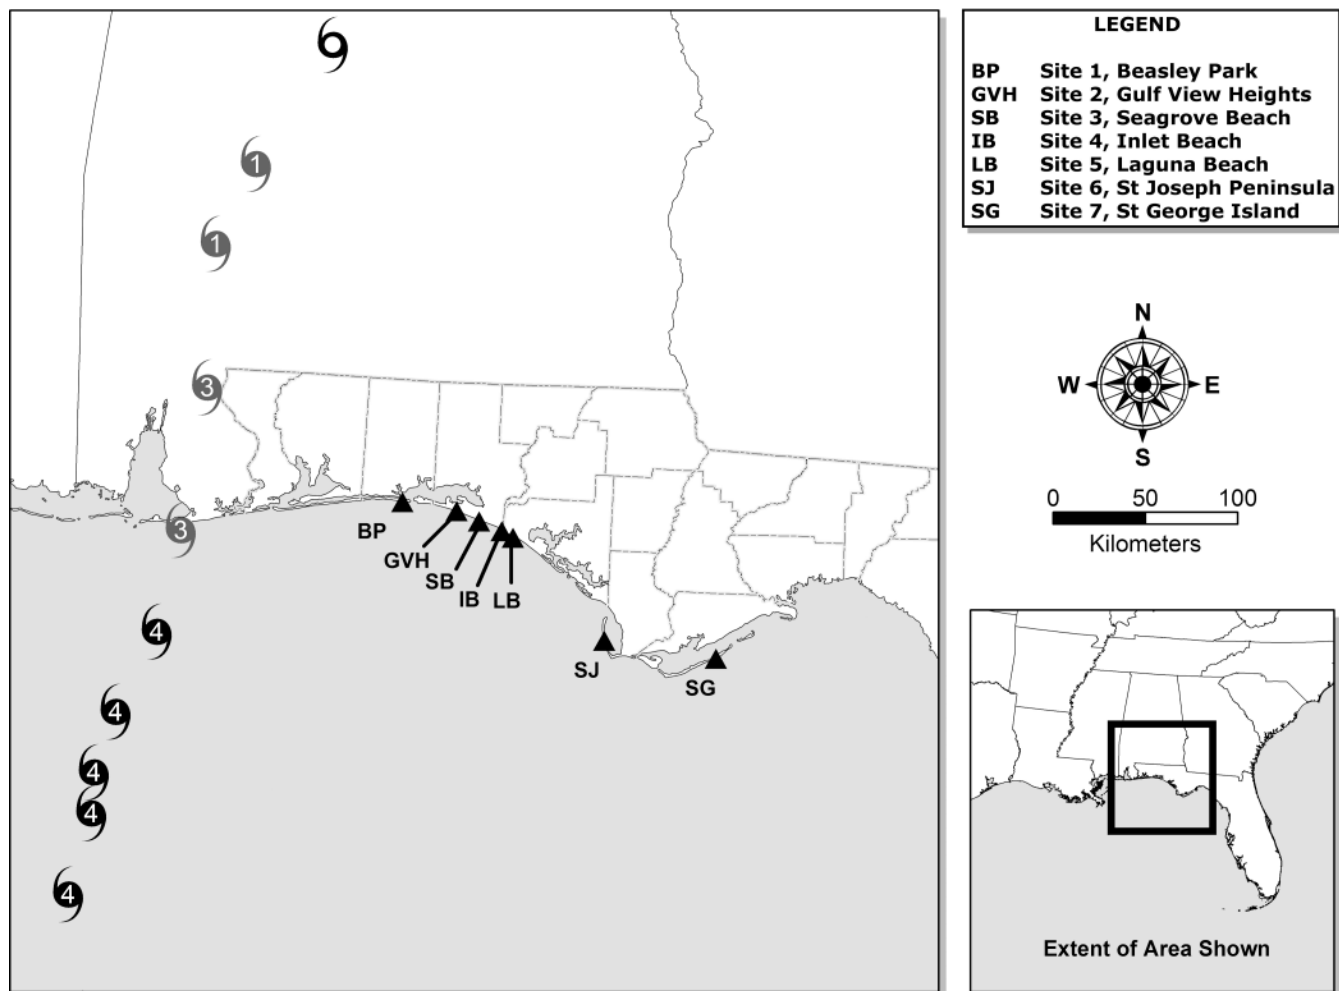
Figure 1. Track and intensity of Hurricane Ivan and locations of the seven study sites.

The study area extends along the eastern side (with on-shore wind) of the hurricane from Fort Walton Beach to St. George Island (Figure 1). Seven study sites along the 200-km stretch of coast were selected. All the study sites are located along the barrier island coast and are composed of dominantly fine to medium quartz sand with variable amounts of heavy minerals (STONE, 1991; USDA-SCS, 1984). For the convenience of discussion, the sites are labeled 1 through 7 from west to east. Site 1, the westernmost site, is located at Beasley Park (referred to as S1\_BP in the following) in Fort Walton Beach, approximately 120 km from the center of the storm at landfall. Measuring from the eastern side of the hurricane eyewall at landfall, S1\_BP is roughly 80 km to the east. Because of the close proximity to the hurricane center, both significant dune erosion and overwash occurred (Figure 2).

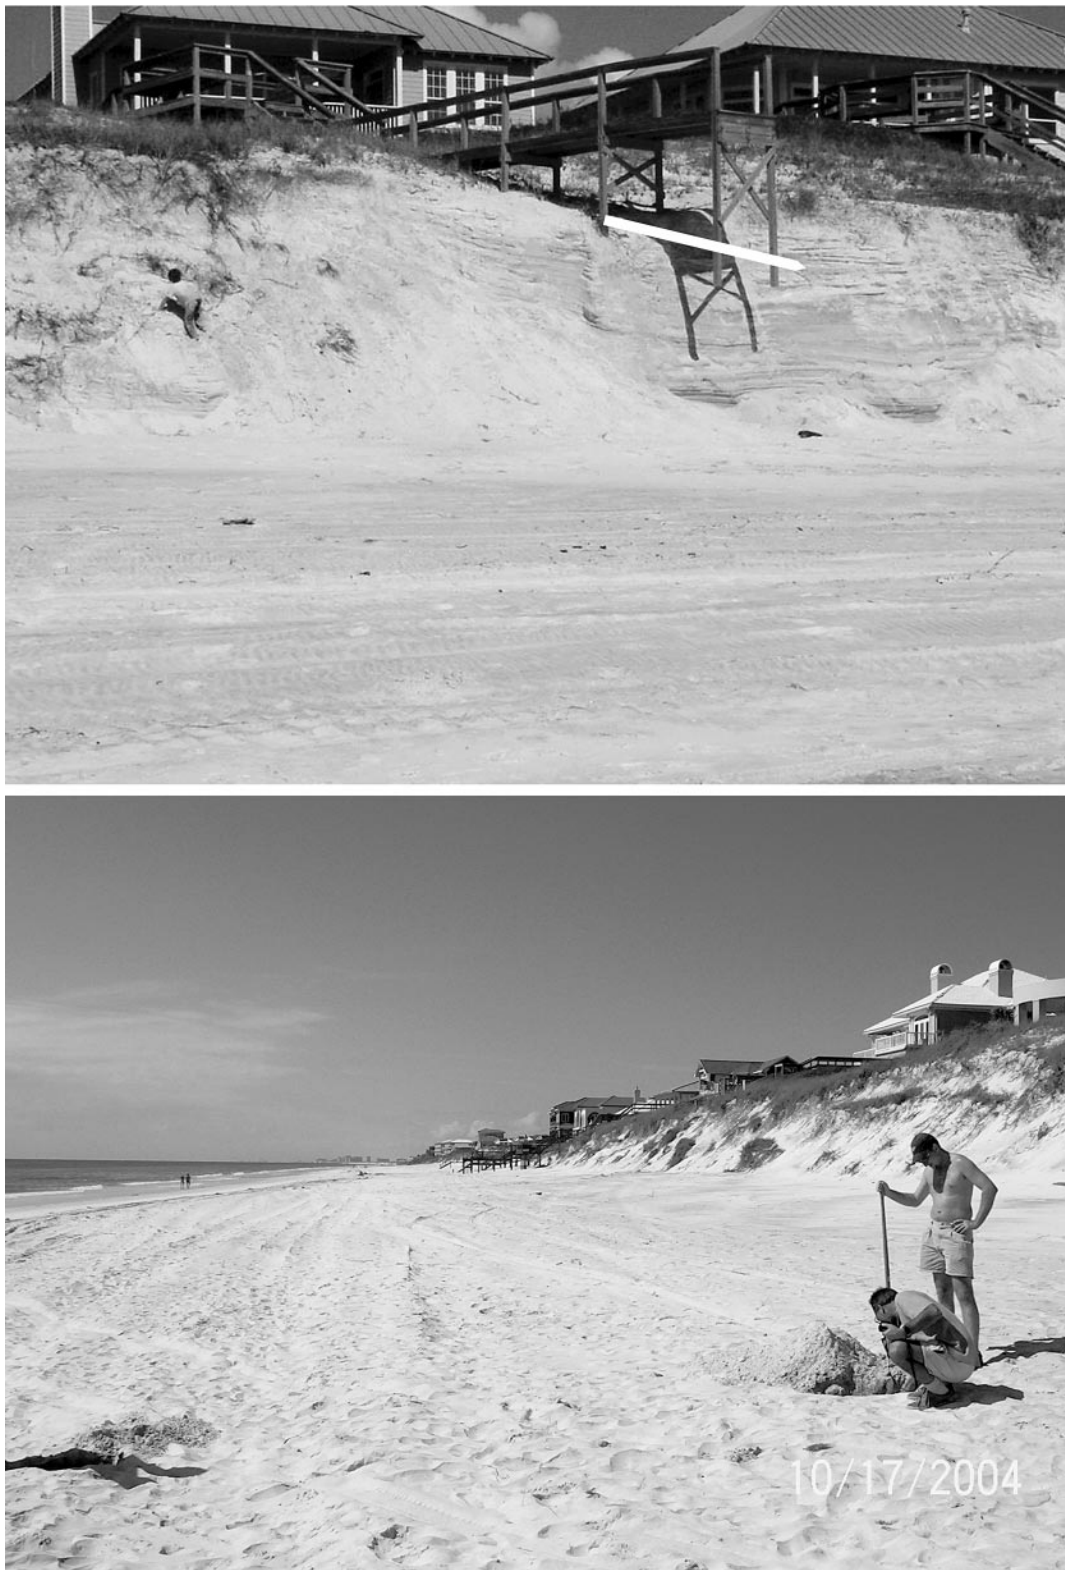
Figure 3. Study site S2-GVH. Upper: dune scarp with white line indicates prestorm dune level at the walkover structure (distinguished by the different color of the wood); lower: extensive dune scarp and locations of the trenches. Photo was taken on October 17, 2004, 30 d poststorm.

landfall, or 110 km from the eastern eyewall. Significant and extensive dune erosion occurred at this site, damaging nearly all the wood overwalks (Figure 3). An array of four trenches was established to examine the subaerial storm deposit.

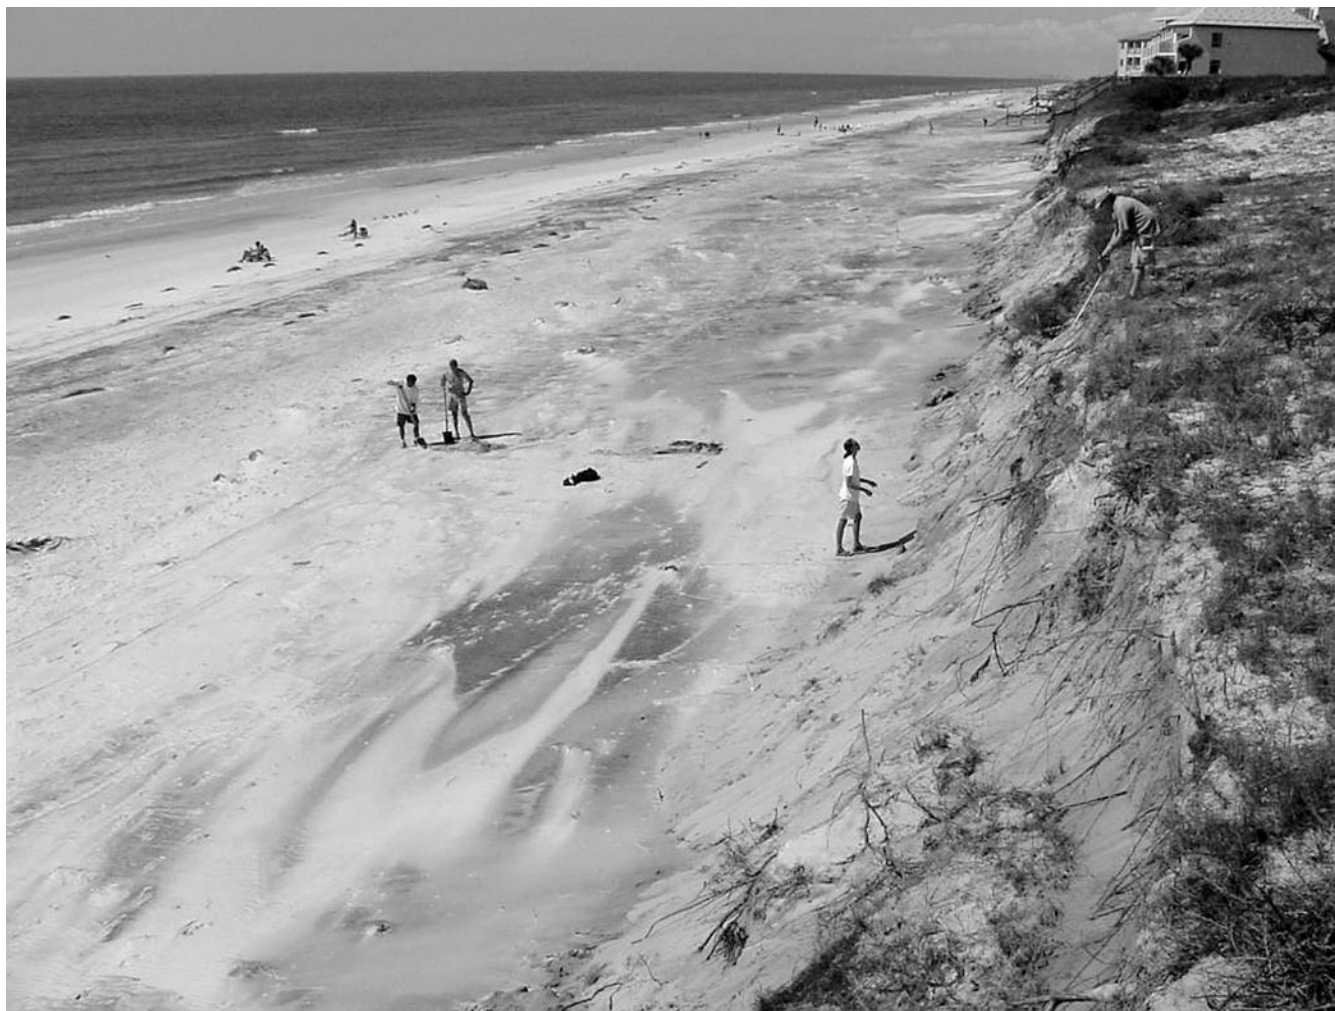
Figure 4. Study site 3.SB. Note the high concentration of dark heavy minerals on the beach, which is considerably different from the white sand at the rest of the study sites. Photo was taken on October 17, 2004, 30 d poststorm.

The third study site is located at Seagrove Beach (S3\_SB), roughly 160 km east of the storm center, or 120 km from the eastern eyewall. An array of five trenches was excavated. The Seagrove site is considerably different from the other sites in that the erosion into the Pleistocene dune field exposed layers of dark, heavy minerals, including ilmenite, staurolite, kyanite, zircon, and rutile (STAPOR, 1973; USDA-SCS, 1989). Several layers of the heavy minerals were exposed, with the bottom one located just beneath the present backbeach. Dark, heavy minerals were distributed rather extensively on the surface of the beach (Figure 4). DOUGHERTY, FITZGERALD, and BUYNEVICH (2004) and BUYNEVICH, FITZGERALD, and VAN HETEREN (2004) found that heavy mineral layers tend to concentrate at the base of storm deposits and correlate well with prominent layering in ground penetration radar profiles.

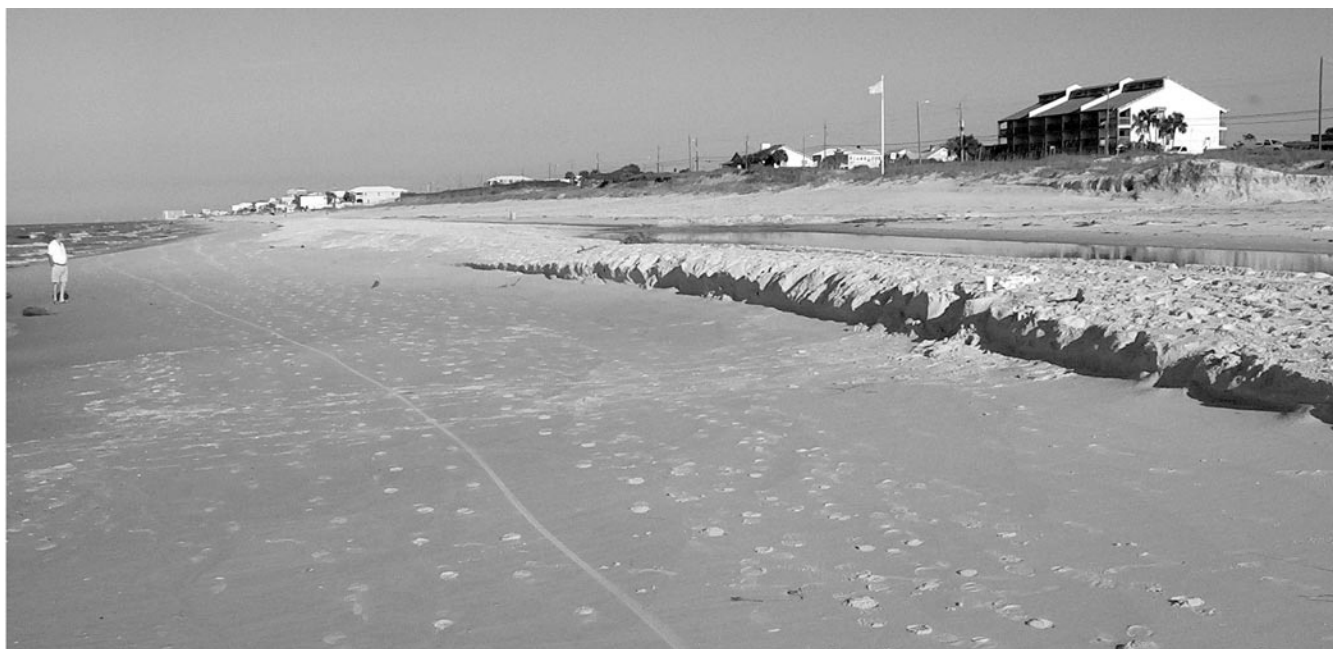
Figure 6. Study site S5\_LB. The beach scarp in the middle of the photo is not related to the storm. The dune scarp was caused by the storm impact. Photo was taken a month after the impact.

The fifth site is located at Laguna Beach (S5\_LB), 180 km east of the storm center, or 140 km from the eastern eyewall. Compared to the west four sites, dune erosion at the Laguna Beach site is much less severe. The dune scarps are typically low and discontinuous (Figure 6). An array of five trenches was excavated to examine the characteristics of the storm deposit.

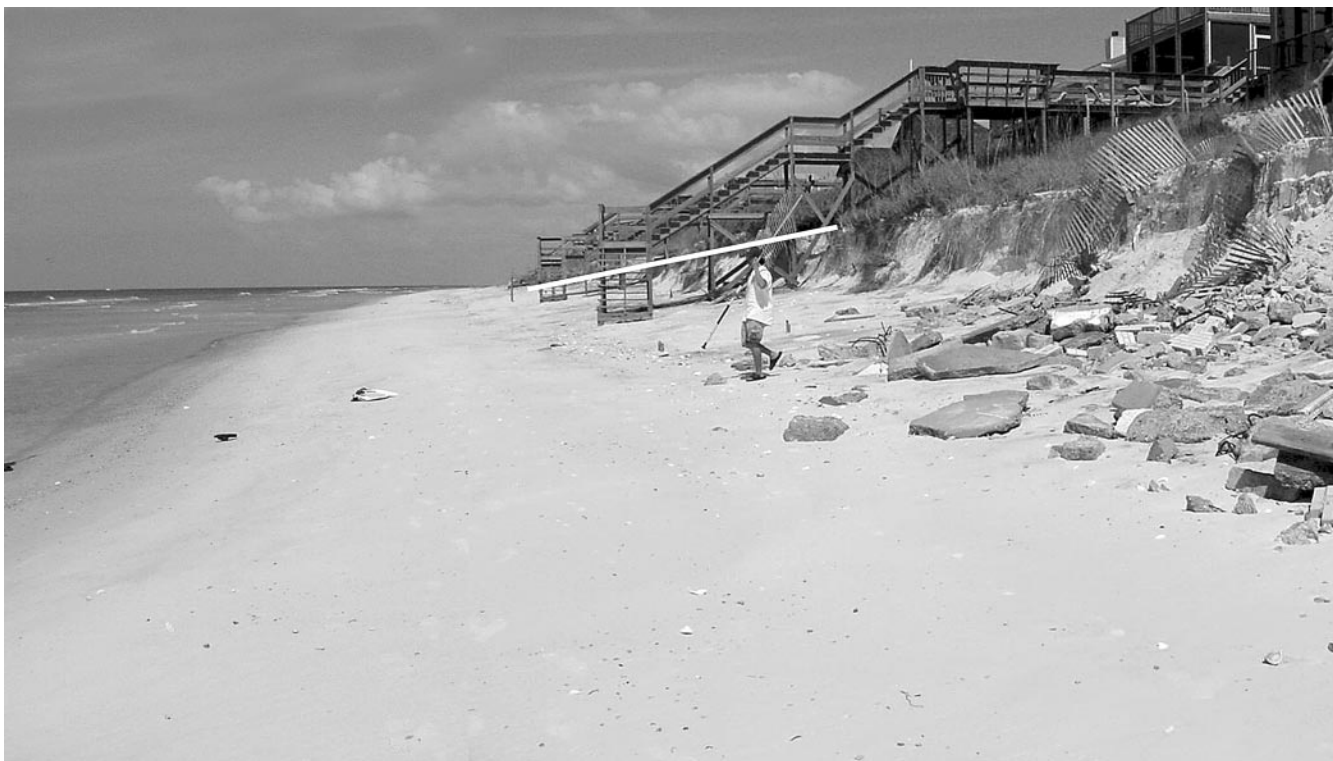
Figure 7. Study site S6\_SJ2 at St. Joseph Peninsula looking north. The white line shows the prestorm dune level at the dune walkover (indicated by the different color of the wood). Photo was taken on September 23, 2004, a week after the Ivan impact.

The sixth site is located on St. Joseph Peninsula (S6\_SJ), 240 km east of the storm center, or 200 km from the eastern eyewall. In contrast to the previous east-west-oriented five sites, St. Joseph Peninsula is oriented roughly north-south, and protrudes approximately 60 km farther south into the Gulf of Mexico (Figure 1). STAPOR (1973) found that quartz beach sands in the St. Joseph Spit region contain on average 0.1% heavy minerals by weight. One cross-island profile (S6\_SJ1) and one beach/dune profile (S6\_SJ2) were surveyed (Figure 7). Significant structural damage to the residential buildings occurred in the vicinity of S6\_SJ2, largely because of the narrow and erosional nature of the prestorm beach. No significant overwash occurred on the island, probably due in large part to its well-established dune field in conjunction with the island's long distance from the hurricane center. Two trenches were excavated at S6\_SJ1 and three at S6\_SJ2.

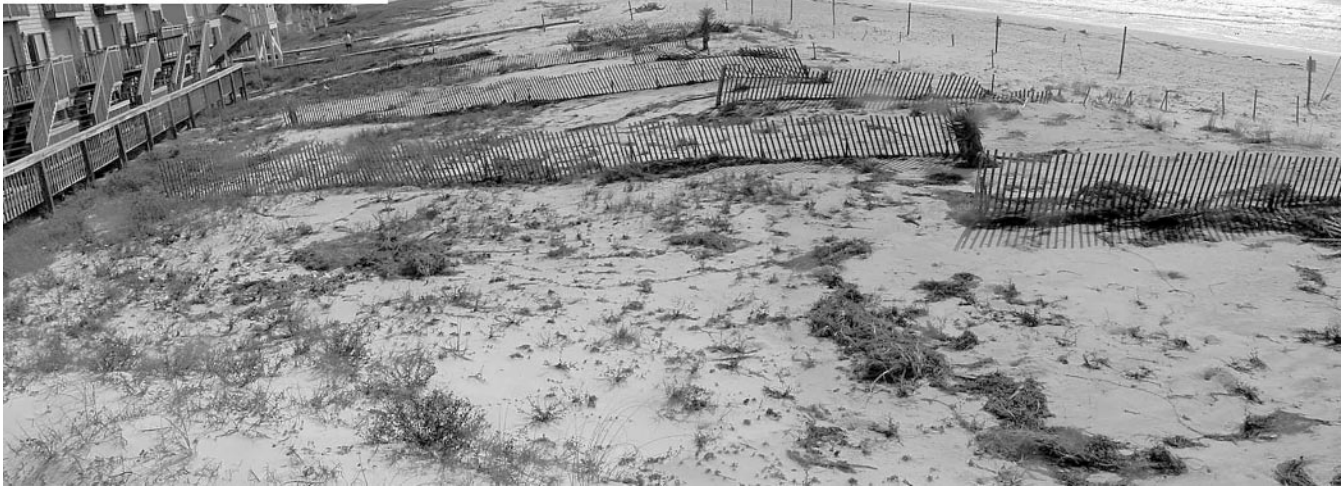
Figure 8. Study site S7\_SG. Profile S7\_SG1 is located toward the top of the photo and S7\_SG2 at the bottom. Minor dune scarping occurred at this site. Photo was taken on September 23, 2004, 1 week after Ivan impact.

The seventh and easternmost site is located on St. George Island (S7\_SG), 300 km east of the storm center, or 260 km from the eastern eyewall. The island is oriented roughly northeast-southwest, and protrudes approximately 80 km farther south into the Gulf of Mexico, as compared to the western five sites. Two beach profiles were surveyed (Figure 8). The first profile, S7\_SG1, extends from the base of a 3-story building with no frontal dune. The second profile, S7\_SG2, has a low artificial dune in front.

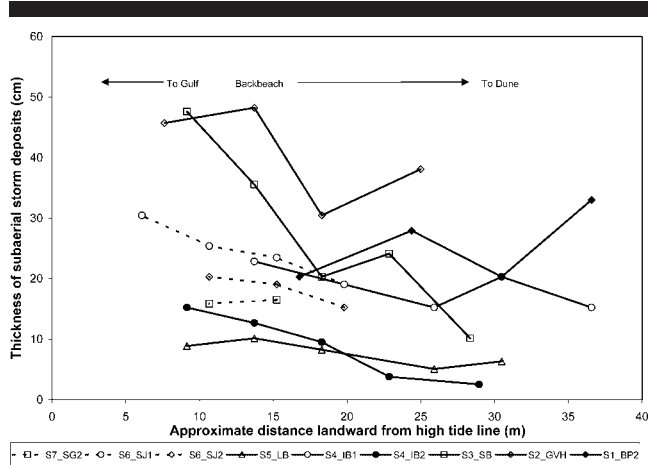
Figure 15. Thickness of storm deposits at all the study sites.

storm deposit ranged from 10 cm to nearly 50 cm (Figure 15). A general landward thinning trend was measured along most of the trench transects. The landward-most trenches were located approximately 5 m seaward of the poststorm dune field or scarp, except at S7\_SG1 and S6\_SJ1 where dune scarping was low and discontinuous. At the western sites, S1\_BP, S2\_GVH, and S3\_SB, the landwardmost trench is located within the prestorm dune field. A thicker layer of storm deposit was measured at the landwardmost trenches at S1\_BP and S2\_GVH. The thicker storm deposit may be attributed to the abundant sand supply from the eroding dune. This trend was not observed at Site 3. The sharp decrease of the storm layer thickness landward was probably caused by the condensed heavy mineral layer (pre-Holocene) at the bottom, limiting the depth of erosion (Figure 14, S3 at the right column).
