Factors controlling the survival of coastal dunes during multiple hurricane impacts in 2004 and 2005: Santa Rosa barrier island, Florida

Vanda Claudino-Sales^{a,1}, Ping Wang^{a,*}, Mark H. Horwitz^b

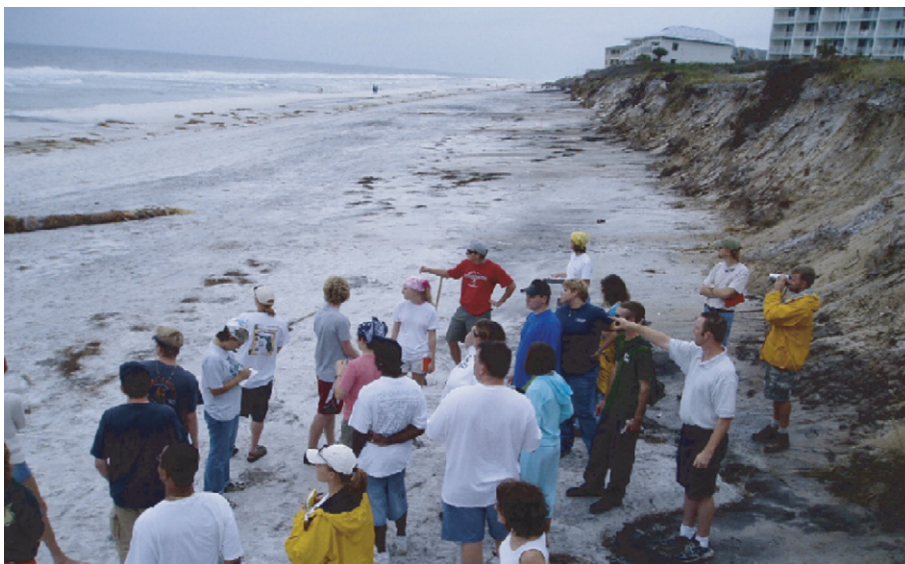
Fig. 1. An extensive dune scarp induced by Hurricane Ivan. The scarp extends nearly continuously for approximately 40 km. The photo was taken about 40 km east of Santa Rosa Island.

overwash. A collision regime can cause tremendous and extensive damage to dune fields in the form of dune scarping (Fig. 1). Wang et al. (2006) discussed the extensive and continuous scarping caused by Hurricane Ivan along the northwestern Florida coast, east of the Santa Rosa Island study area. When R_{HIGH} is higher than D_{HIGH} but R_{LOW} is lower than D_{HIGH} , the third impact scale, *overwash regime* occurs (Morton and Sallenger, 2003). The fourth and most severe impact, the *inundation regime*, occurs when R_{LOW} exceeds D_{HIGH} . Low-lying barrier islands are especially susceptible to inundation regime (Dingler and Reiss, 1995). This paper focuses on the dramatic and regional-scale destruction and survival of dunefields impacted by overwash and inundation regimes.

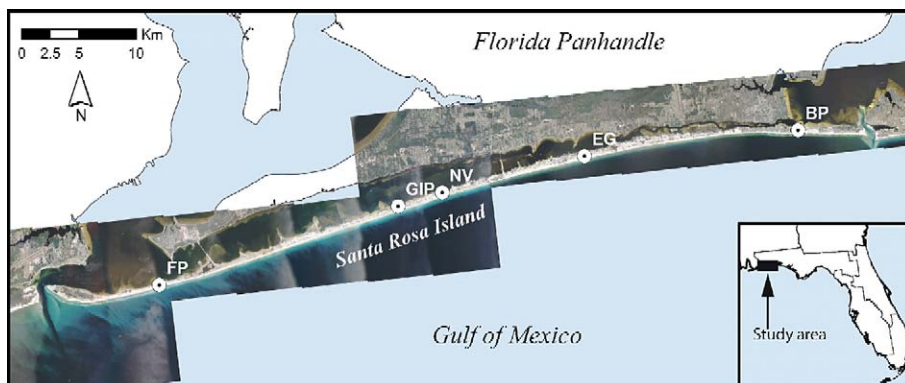
Fig. 2. Pre-Ivan aerial photo mosaic of Santa Rosa Island showing the location of the five study sites: FP—Fort Pickens State Park, GIP—Gulf Island National Sea Shore, NV—Navarre Beach, EG—Eglin Air Force Base, BP—Beasley Park.

The 2004 and 2005 Atlantic and Gulf of Mexico hurricane seasons were extremely active and imposed tremendous impacts along the Florida coasts (Stone et al., 2005; Wang et al., 2005, 2006; Wang and Horwitz, 2007). Two of the major hurricanes, Ivan in 2004 and Dennis in 2005, impacted the study areas directly, and are the focus of this study on barrier island dunes (Fig. 2).

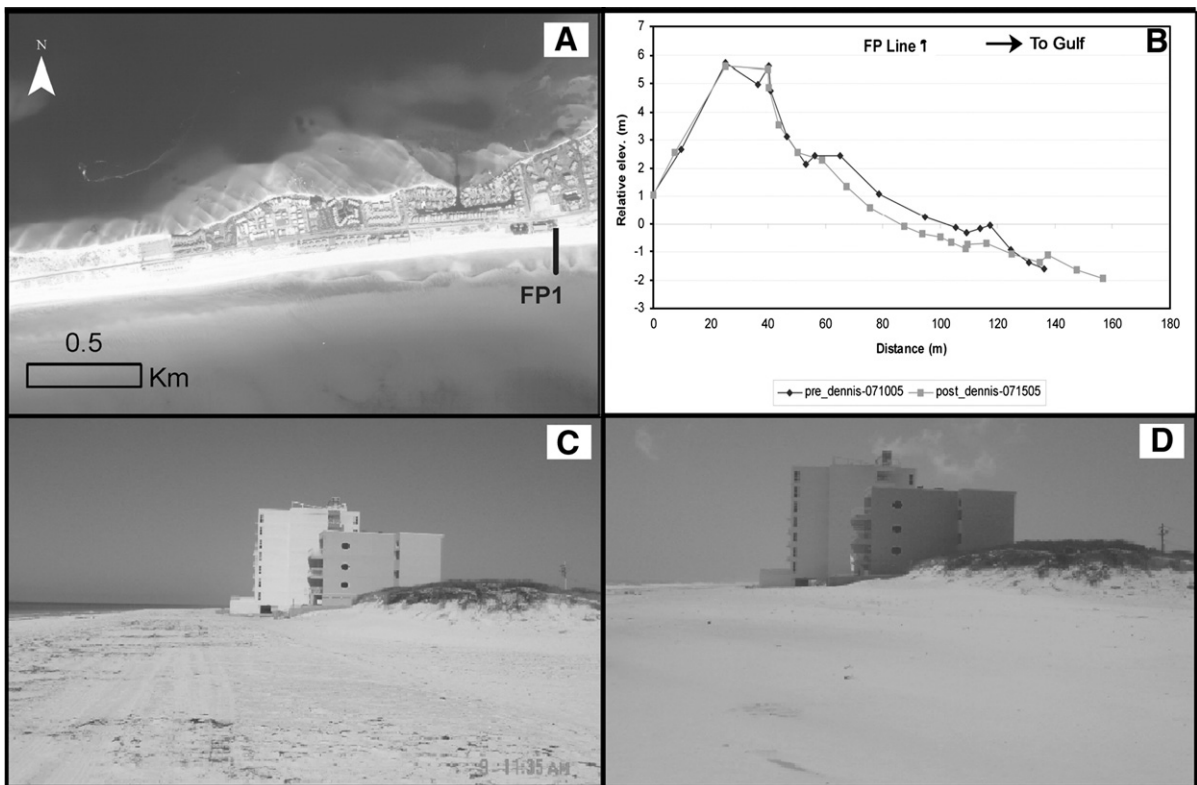
Fig. 7. A beach-dune profile immediately east of the FP study site. A: aerial view of the established dune. B: pre-Dennis and post-Dennis profiles. C: pre-Dennis ground view. D: post-Dennis ground view.

One pre- and post-Dennis dune profile was surveyed along the far eastern portion of the study area (Fig. 7). The profile extends across an isolated established dune that survived Ivan (Fig. 7B). While Dennis' impact included a significant amount of beach erosion (Fig. 7C, D), impact to the dune was minimal and limited to scarping along the Gulf-side dune face.

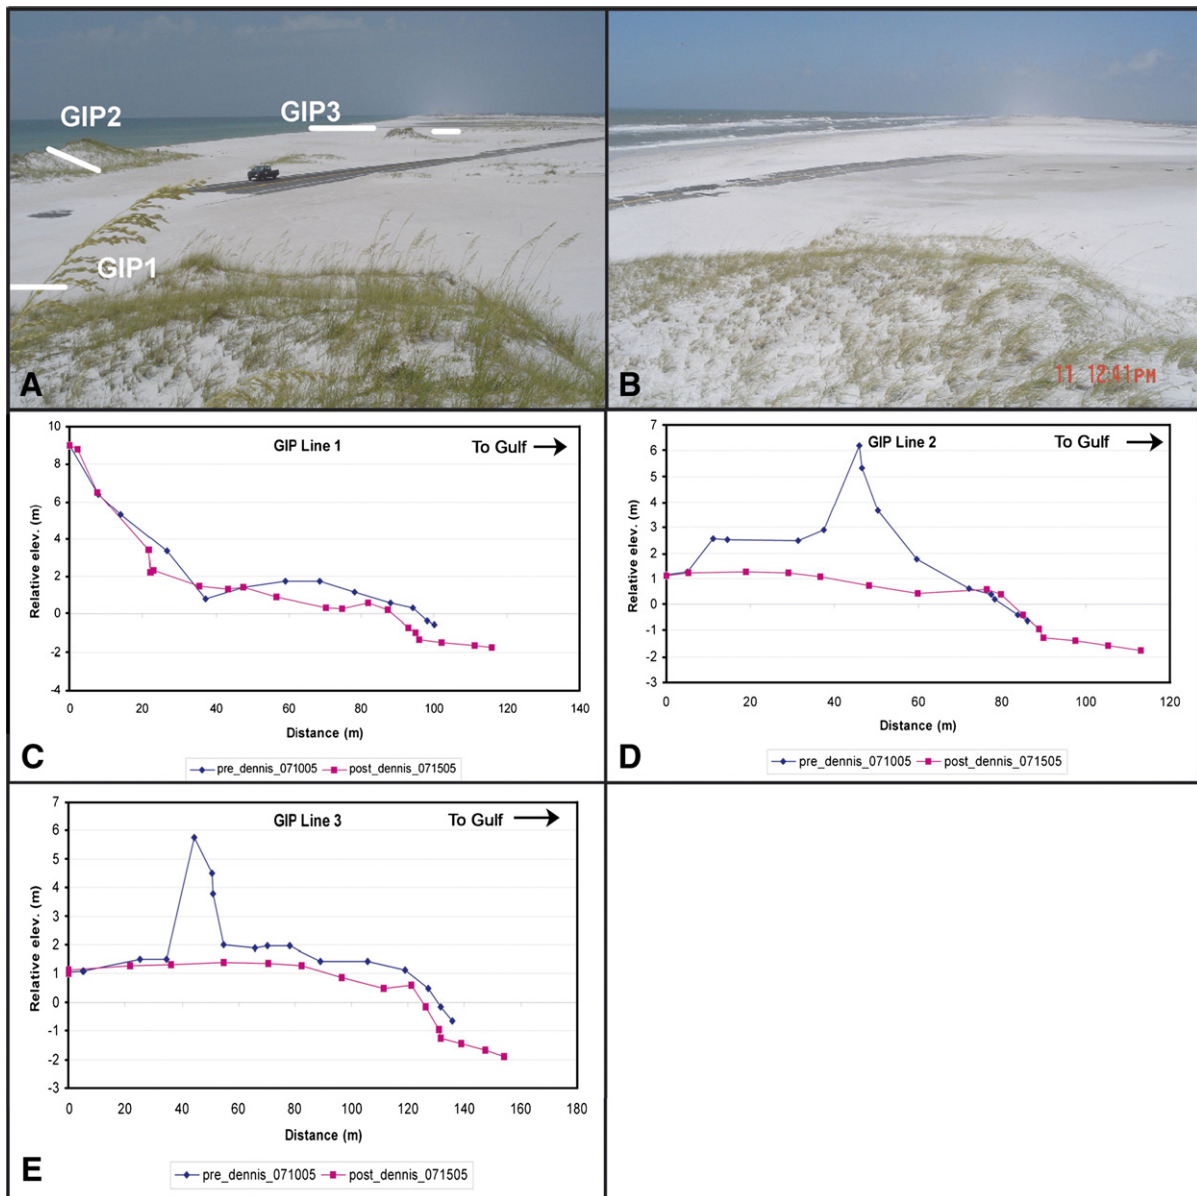
Fig. 11. Pre-Dennis and post-Dennis beach–dune profiles across post-Ivan isolated dunes. A: pre-Dennis ground view of the three dunes (pick-up truck shown for scale). B: post-Dennis ground view of the same area with one surviving dune. C: pre- and post-Dennis profiles at GIP1. D: pre- and post-Dennis profiles at GIP2. E: pre- and post-Dennis profiles at GIP3. Note the variations in dune size and distance to the Gulf shoreline.

Three dune profiles were surveyed immediately pre- and post-Dennis impact (Fig. 11). A survey benchmark established at the crest of a 9 m-high dune during the post-Ivan road re-construction fortunately survived Dennis, and was used for vertical control for all three profiles. The first dune profile, GIP1, extended Gulfward from the benchmark. The dune along GIP1 largely survived Dennis although a scarp nearly 2 m-high developed along its seaward face (Fig. 11C). Substantial beach erosion occurred seaward of the dune. The second dune profile, GIP2, is located about 100 m west of GIP1. The profile extended across a 6.5 m-high isolated incipient dune (Fig. 11A, D), situated about 20 m landward of the Gulf shoreline. This relatively large dune (pick-up truck in photo for scale) isolated by Ivan, was completely eroded by Dennis, leaving a flat washover platform in its place (Fig. 11B, D). The third dune profile, GIP3, is located roughly 100 m west of GIP2. This nearly 6 m-high dune was very narrow, about 20 m-wide at the base, and lies approximately 80 m from the Gulf shoreline, similar to the dune at GIP1. Although located much further landward, this narrow dune was completely eroded by Dennis, yielding a largely flat washover platform, similar to that along GIP2 (Fig. 11B, E). In summary, the survival of the post-Ivan dunes seems to be controlled by the distance to the Gulf shoreline, the size of the dune, and its connection to extensive established dunes.

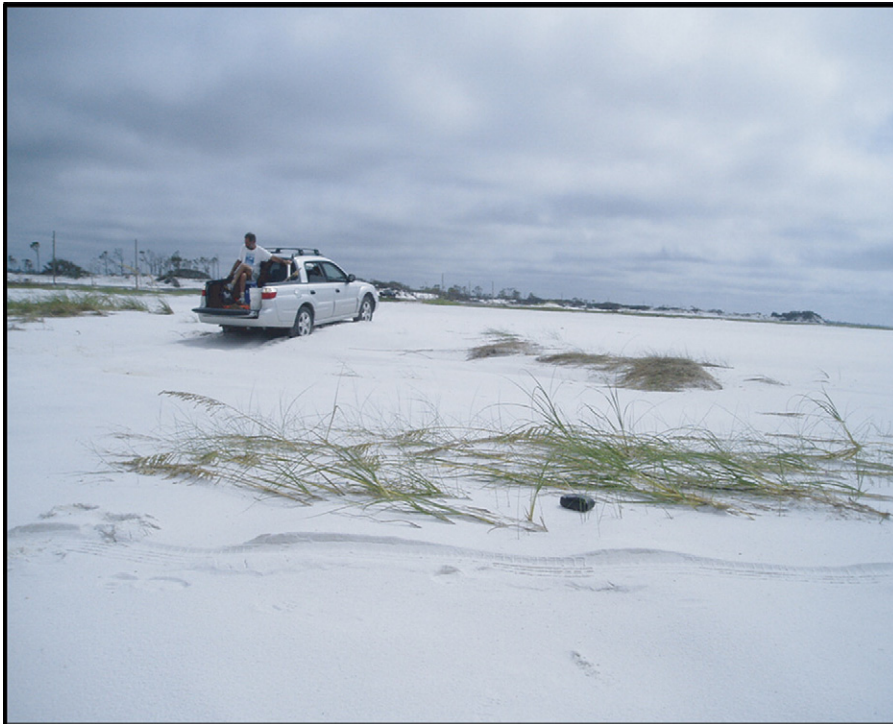
Fig. 14. Ground photo at the EG site, showing partially buried and tilted post-Ivan sea oats. The photo was taken 20 days post-Dennis.

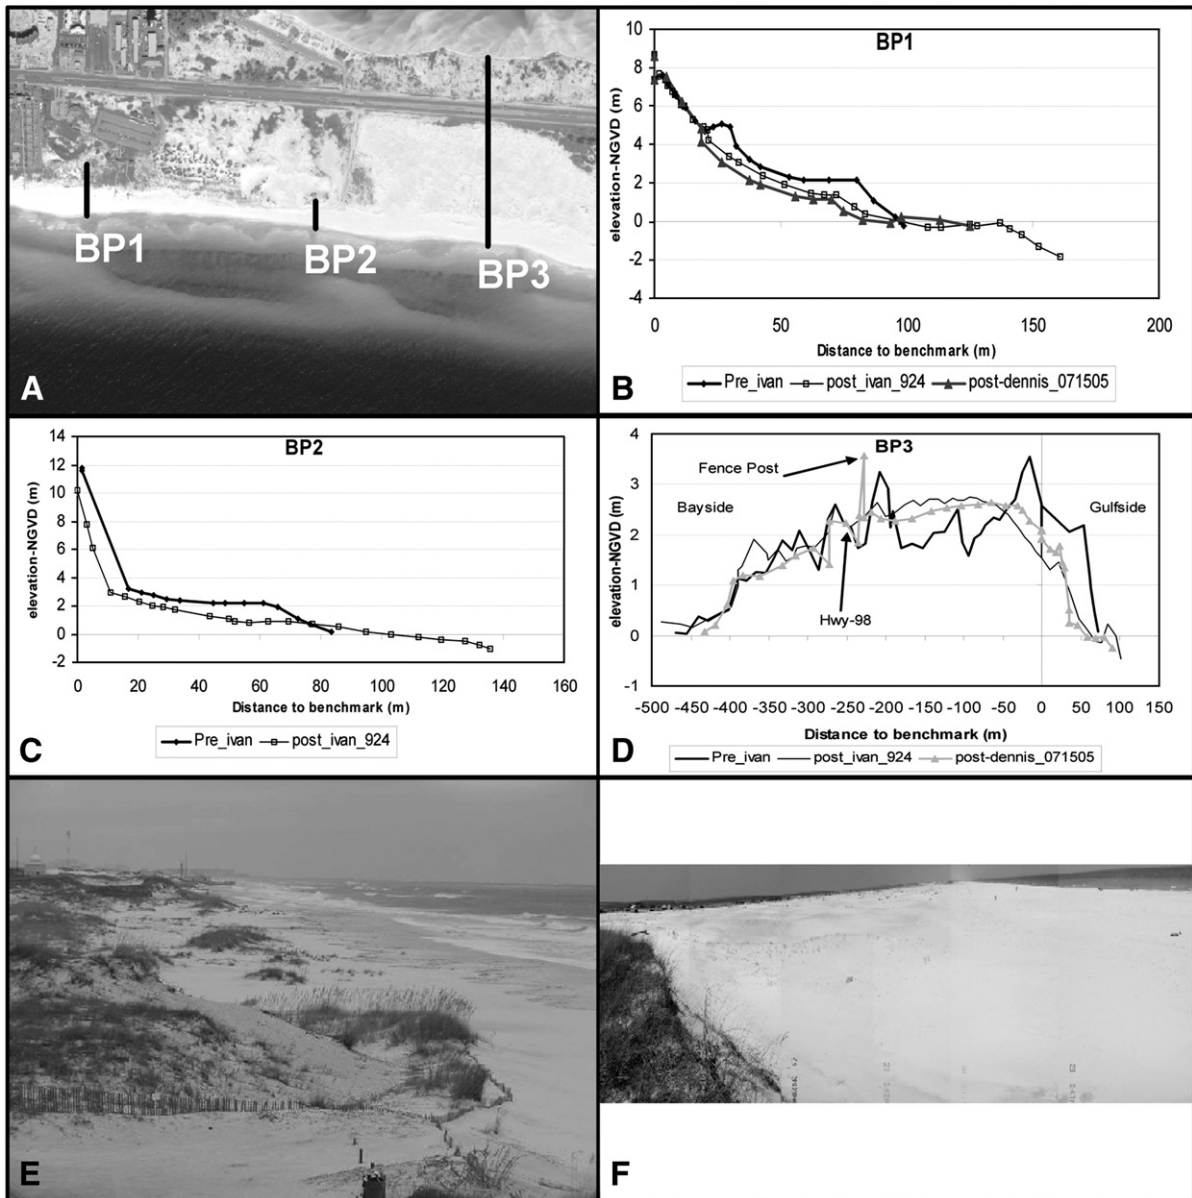
Fig. 17. Pre-Ivan, post-Ivan, and post-Dennis beach–dune profiles at the BP site. A: pre-Ivan aerial view showing the locations of the three profiles. B: pre-Ivan, post-Ivan, and post-Dennis profiles at BP1. C: pre- and post-Ivan profiles at BP2. D: pre-Ivan, post-Ivan, and post-Dennis profiles at BP3. E: pre-Ivan foredunes developed post-Opal (1995). F: ground view of the area in E after Ivan. Note the complete destruction of the post-Opal incipient dunes.

The BP3 site, located in between sections with well-developed established dunes (Fig. 15), presented a weak link and was overwashed by Hurricane Ivan (Fig. 17D, E, and F). Nearly all the incipient dunes that had recovered from Hurricane Opal in 1995 were destroyed and replaced by a flat washover platform. The impacts of Dennis were largely developed over the “footprint” of Ivan, without further extending the area of dune damage, although significant beach erosion was measured (Fig. 17). Overall, little damage to established dunes occurred during both Ivan and Dennis. The BP site illustrates an example of dune destruction by localized overwash processes and a transition from overwash to collision regime.

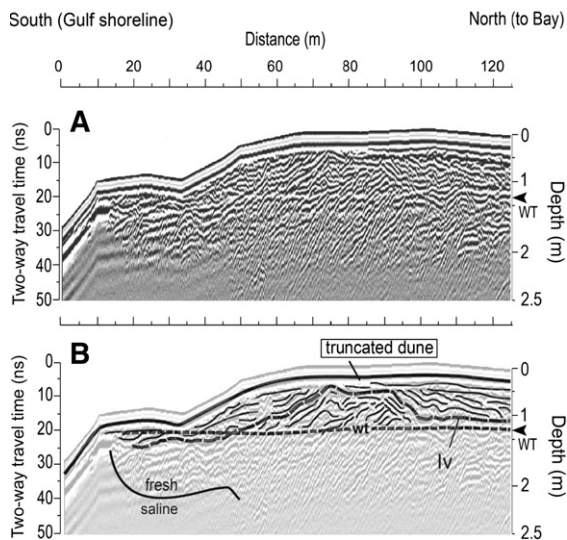
Fig. 18. A GPR profile just west of the BP2 profile, illustrating a truncated dune by a previous storm. WT: water table; Iv: base of Ivan deposit. The depth conversion is based on a velocity of 0.12 m ns^{-1} above the water table, and 0.06 m ns^{-1} below.

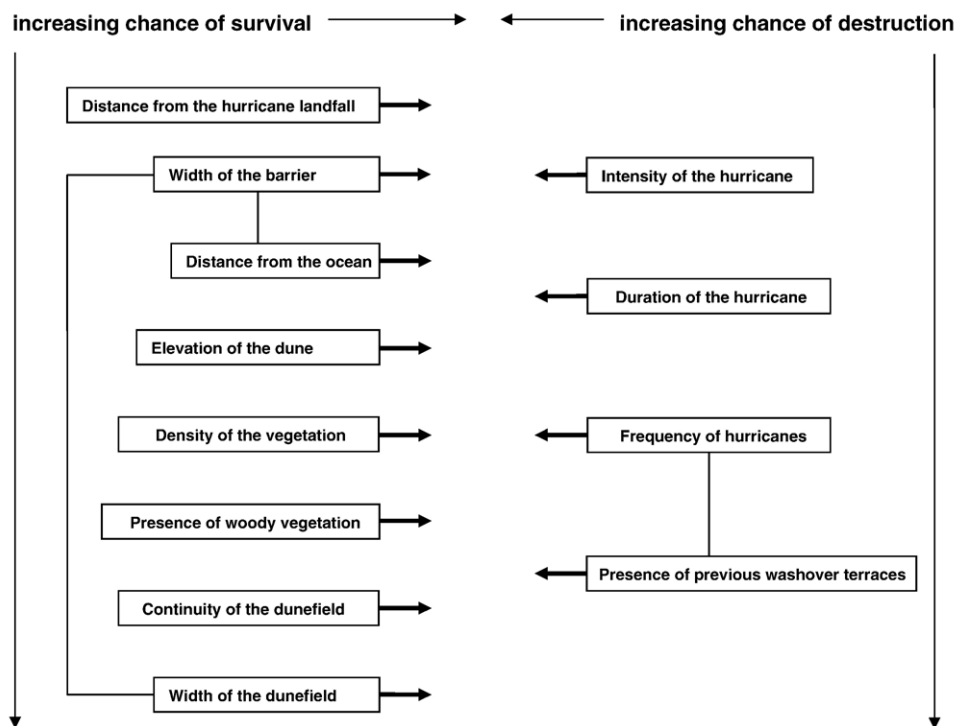
Fig. 19. A conceptual model for the destruction and survival of low-lying barrier-island dunes. The short arrows next to each factor indicate the direction of an increasing trend. Lines indicate the factors that tend to be closely linked. The relative importance of the factors, as determined based on the Santa Rosa Island study, decreases from the top to bottom.
