PALMETTO BEACH LIVING COASTLINE AND COMMUNITY

Project Report

CITY OF TAMPA AUGUST, 2023

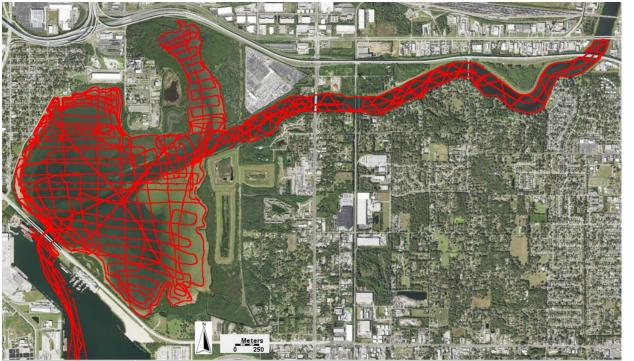
Image: Map of the route taken to record bathymetry data

To accurately compute the tidal circulation within McKay Bay, accurate and up-to-date bathymetry is necessary. A detailed bathymetry survey was conducted by this study using a synchronized precision echo sounder and a RTK GPS. Essential features, including the shallow water along the eastern coast, the un-naturally deep dredged channel through the middle, the limited partial fill of the dredged hole in 2014-2015, were well captured.

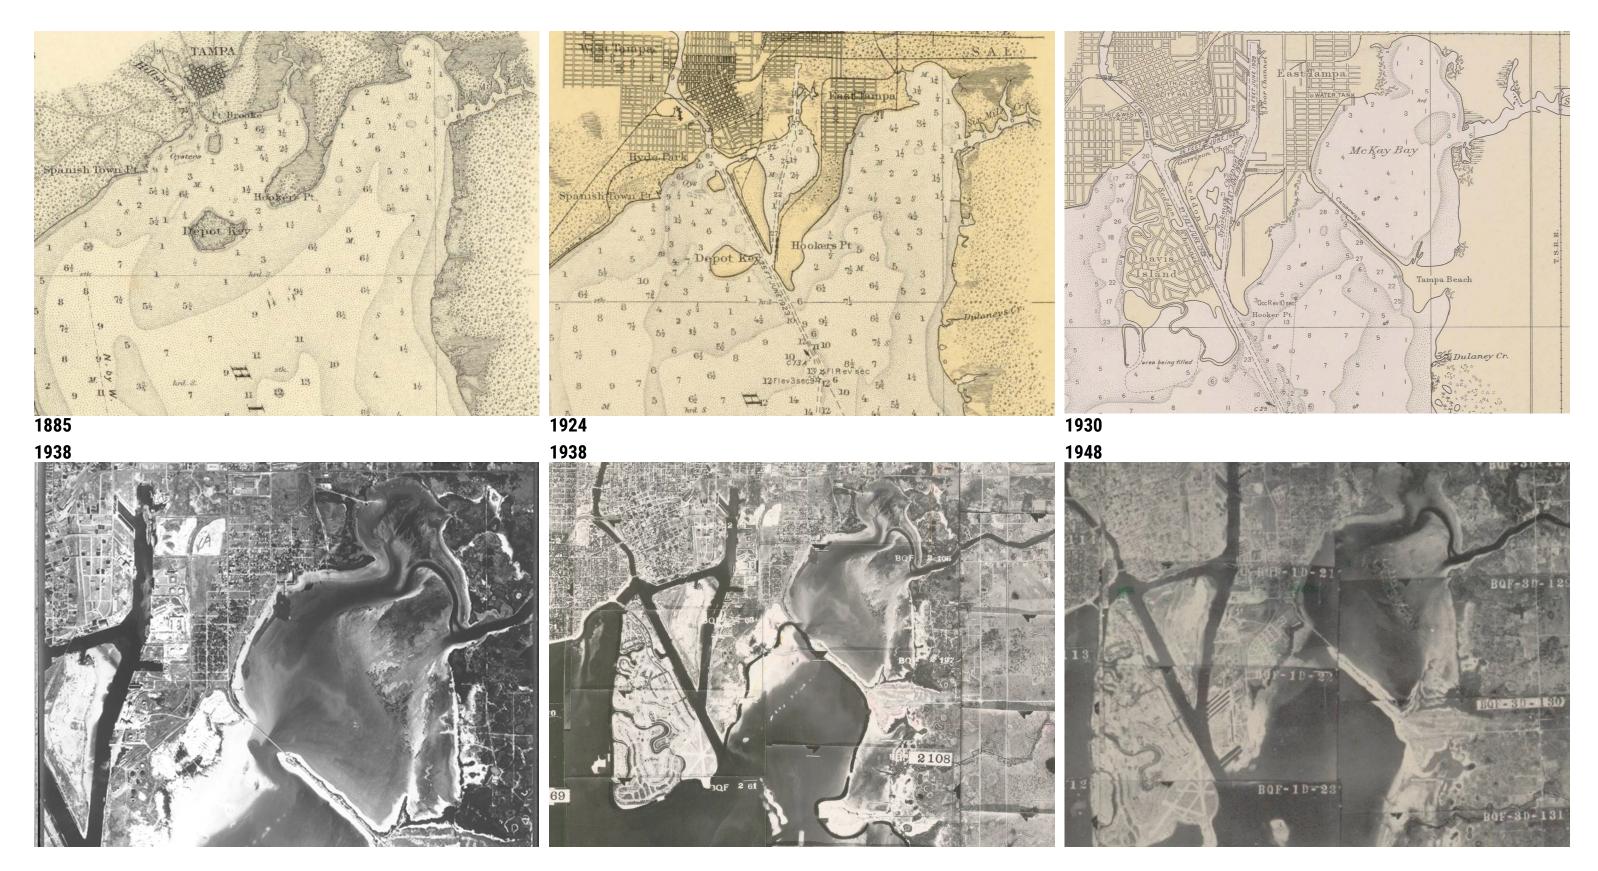
Historical bathymetry maps and aerial photos were collected and analyzed. The pre-engineering conditions is illustrated by the 1885 map. The significant human modification is apparent. Changes directly relevant to the tidal circulation include: The construction of a causeway and a bridge at the wide entrance to the bay in the 1930s and the dredging of the Six-Mile River and the creation of the Bypass Canal in the 1940s.

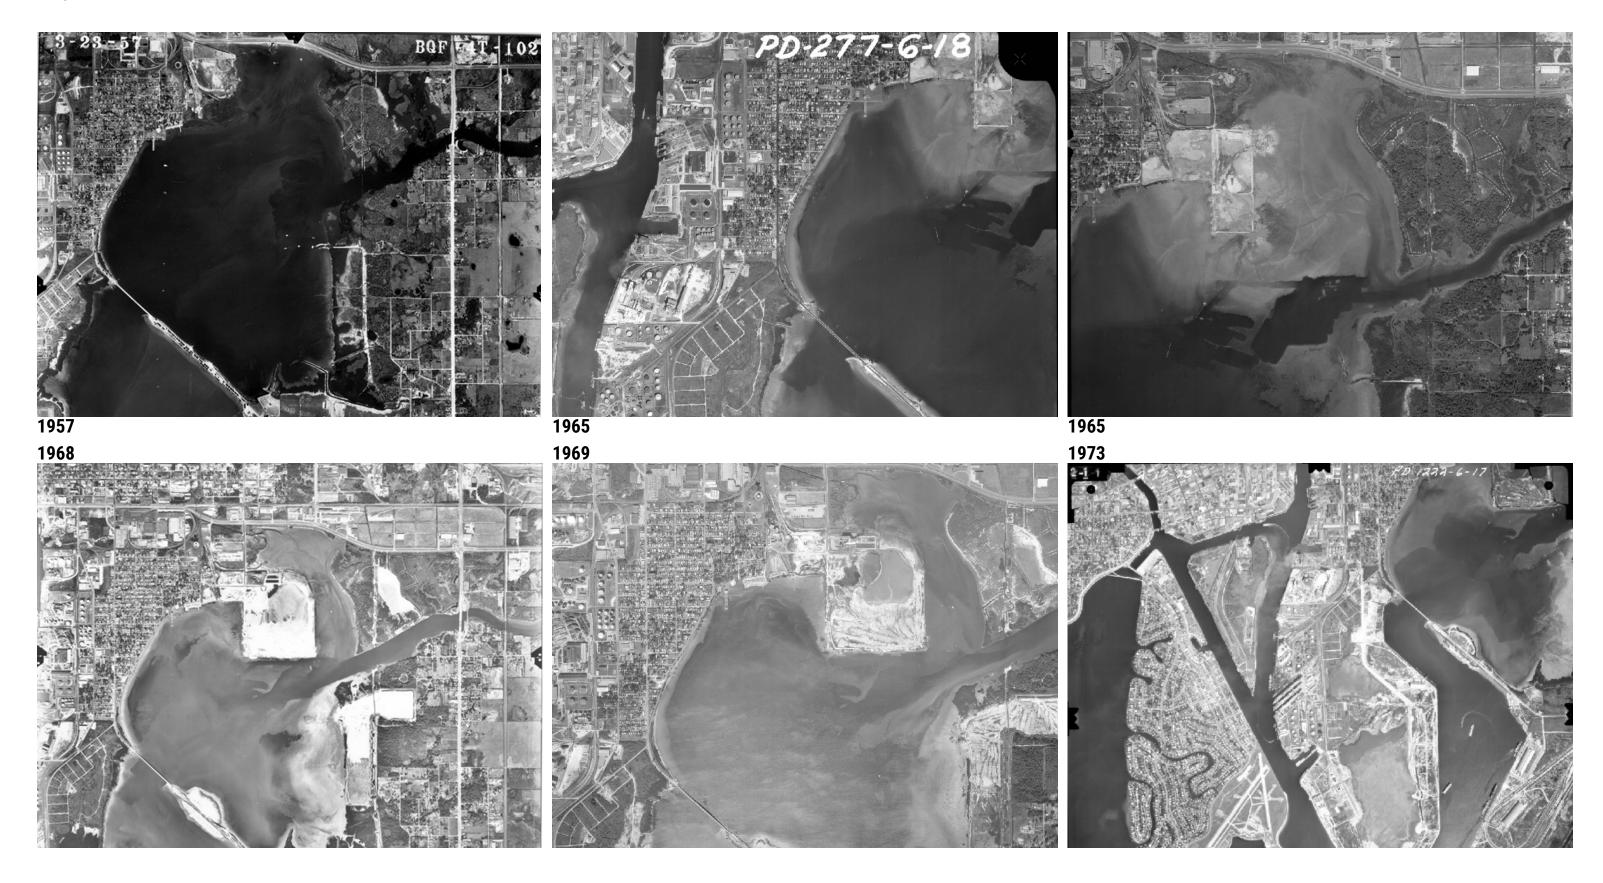
Additional changes to McKay Bay included the removal of the shallow shoal at the mouth of the Six-Mile River and the land fill at the northern end of the bay in the 1950s and continued dredging of the deep channel extending to the causeway bridge in the 1960s and continued landfill.

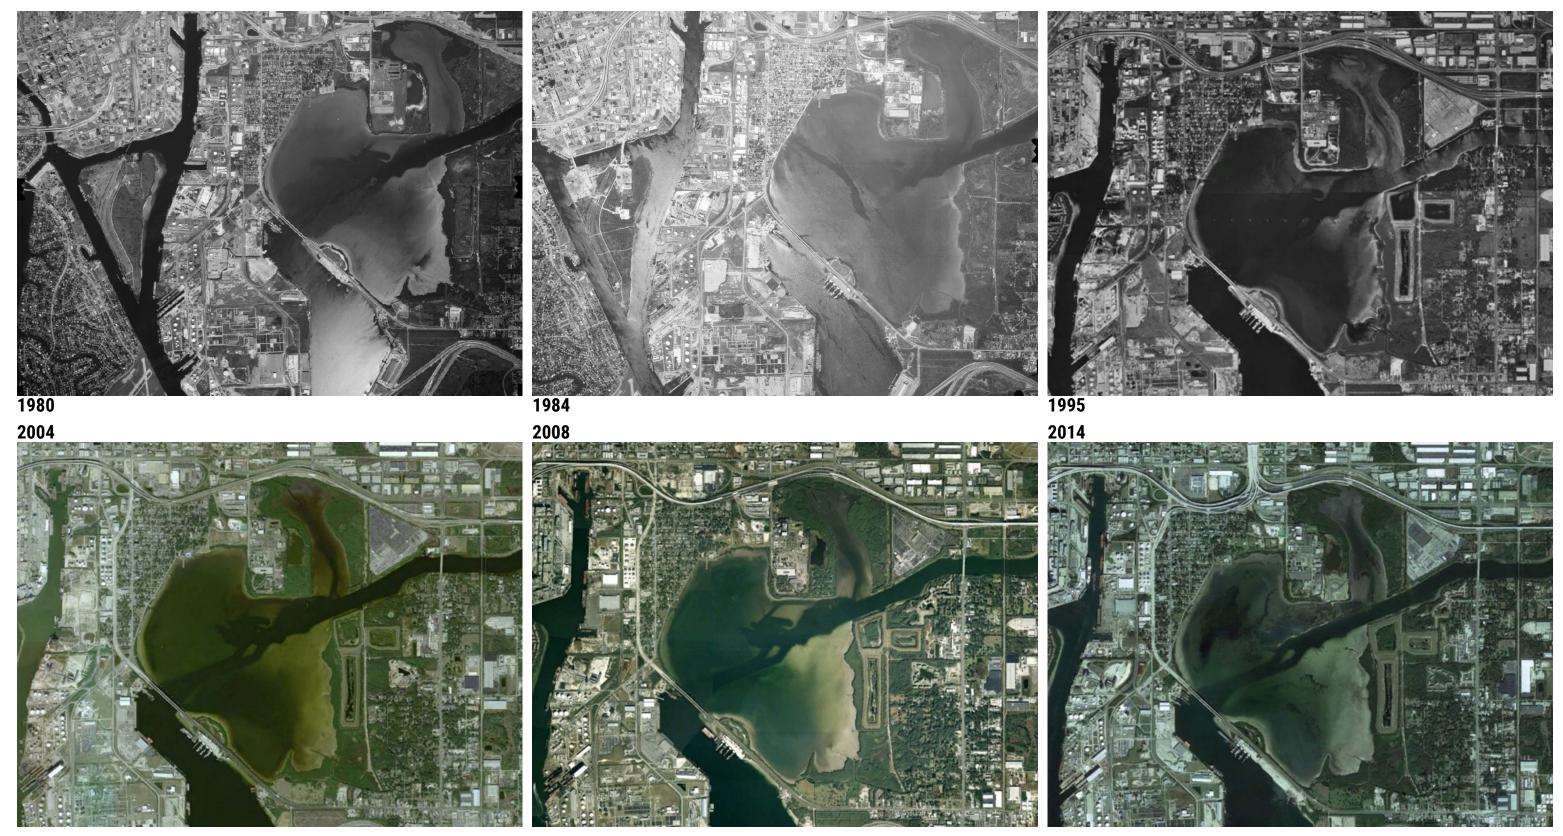
From 1980 to 2014, the Selmon Expressway was constructed and expanded at the northern edge of the bay. Dredged areas are highly visible from aerials. A small dredge fill project took place by 2014. The above dredge and fill of McKay Bay have reduced the surface area of the bay by about 18%. Presently, the bay size is ~3.7 km2. The fill area along the north shore is ~ 0.68 km2. However, the water area reduction by the land fill was more than compensated by the Bypass Canal, which has a surface area of ~ 1.0 km2, a significant increase from the Six-Mile River. Overall, the anthropogenic activities have likely increased the tidal prism of McKay Bay, slightly by increasing the water area.

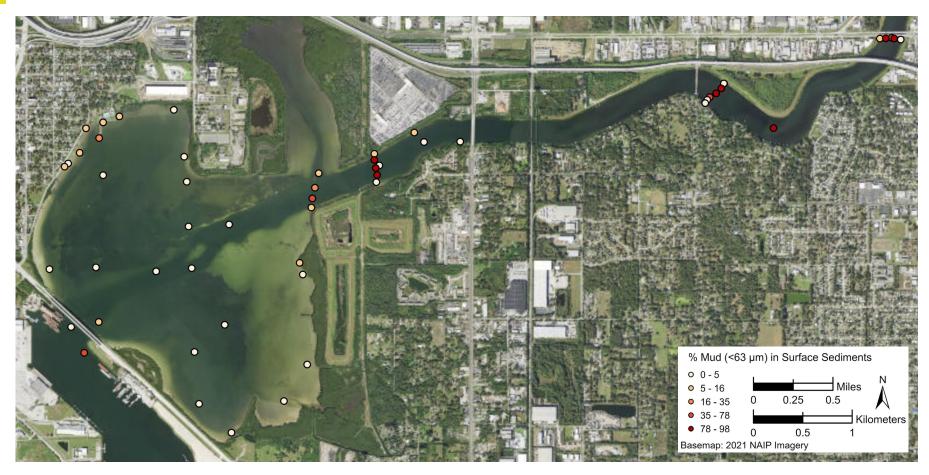
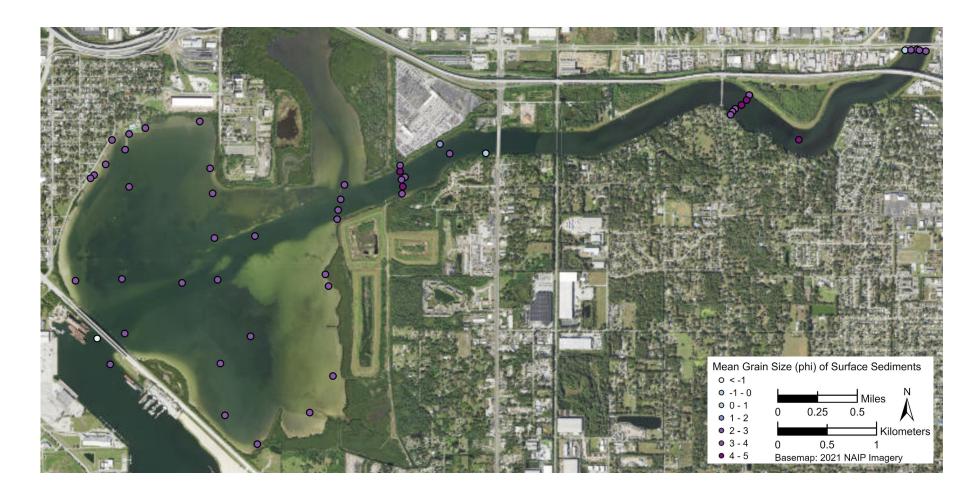
Sixty-four sediment samples were collected and analyzed at the locations shown in the maps.

Concentrations of mud were found within the primary canal trench, at the mouth and estuary edge, and areas upstream. Mud particles were also found, to slightly lesser extent, in the northwest corner of the Bay. This is believed to be associated with stormwater, which captures runoff from the urban environment and directly discharges to the bay at twelve (12) locations along the Bermuda Boulevard seawall.

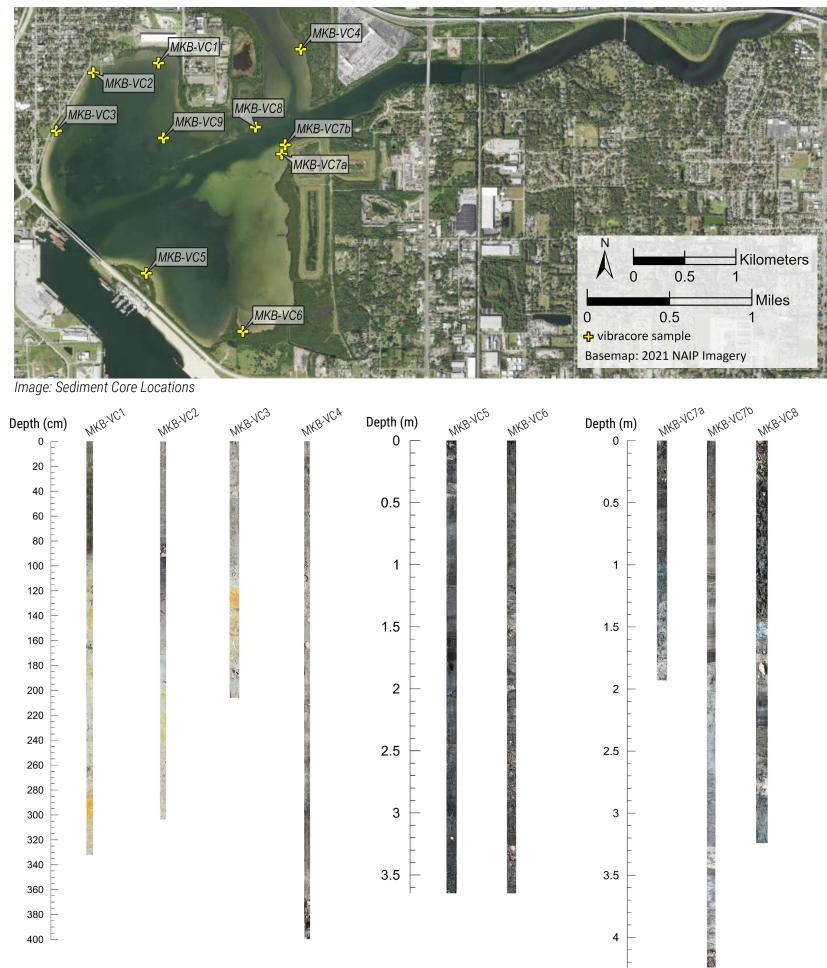
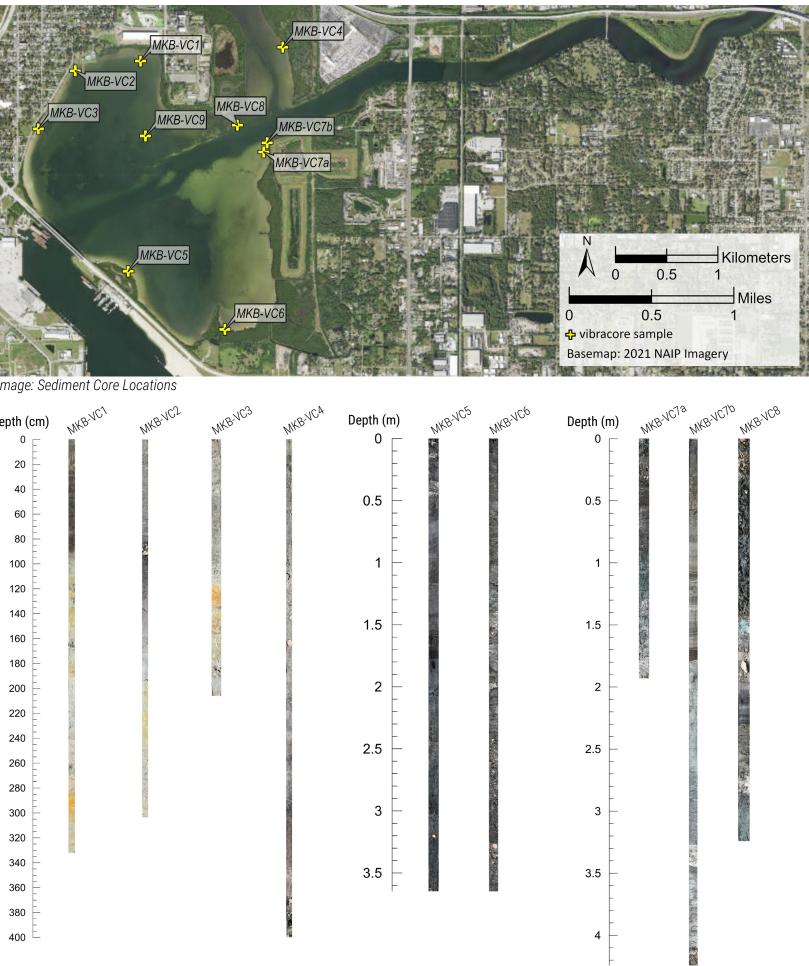
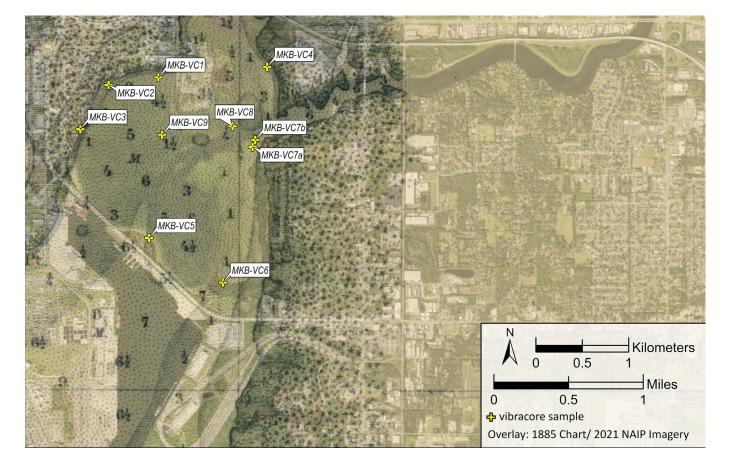
Ten sediment cores were taken at various locations around the bay, with the goal of understanding the geological control of McKay Bay, as well as depicting human modifications. The top right figure shows the core locations marked on the most recent aerial photo. The bottom left figure illustrates the core locations marked on the pre-engineering historical bathymetry map. The photos of the sediment core are shown in the bottom right figure. Cores VC1, VC2, VC3, and VC4 were taken along the northern coast of McKay. The bedrock (brown-yellow layer) is the shallowest in cores VC1 and VC3, while modestly deeper in core VC2. This antecedent geology controls the curvature of the shoreline there with VC1 at the protruding headland and VC2 at the apex of the curve (lower left figure). Un-natural sediments, e.g., rock fragments, were found at around 2 m below surface at cores VC5 and VC6, indication artificial fill material likely associated with the construction of the causeway. Shallow bedrock (light grey layers) was encountered in cores VC7a, VC7b, and VC8. These cores are located on the shallow shoal at the mouth of the Six-Mile River, indicating the geological control of the river and its delta. Overall, the sediment cores revealed the geological control of the McKay Bay and human impact.

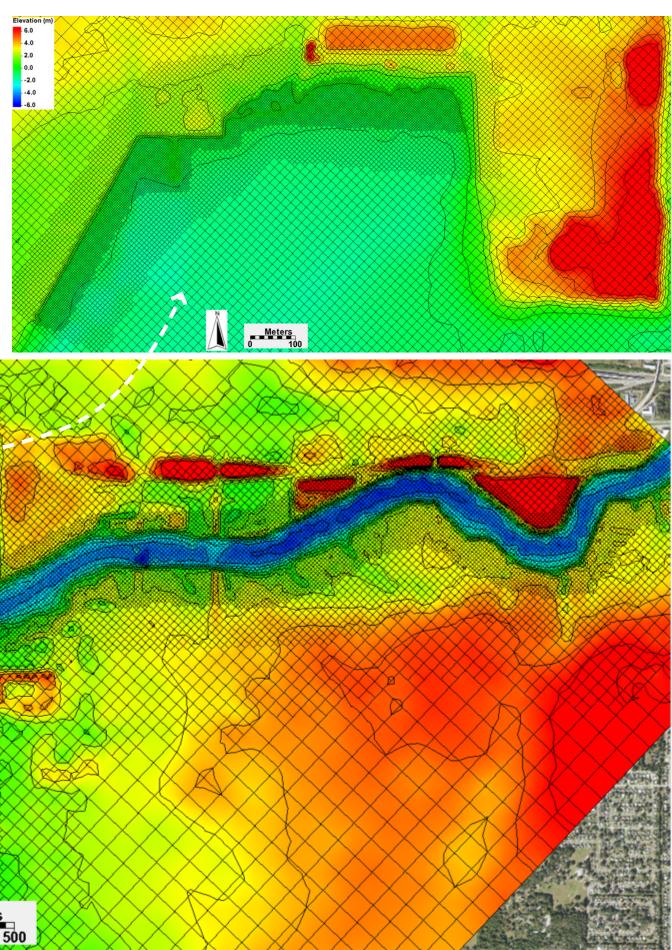
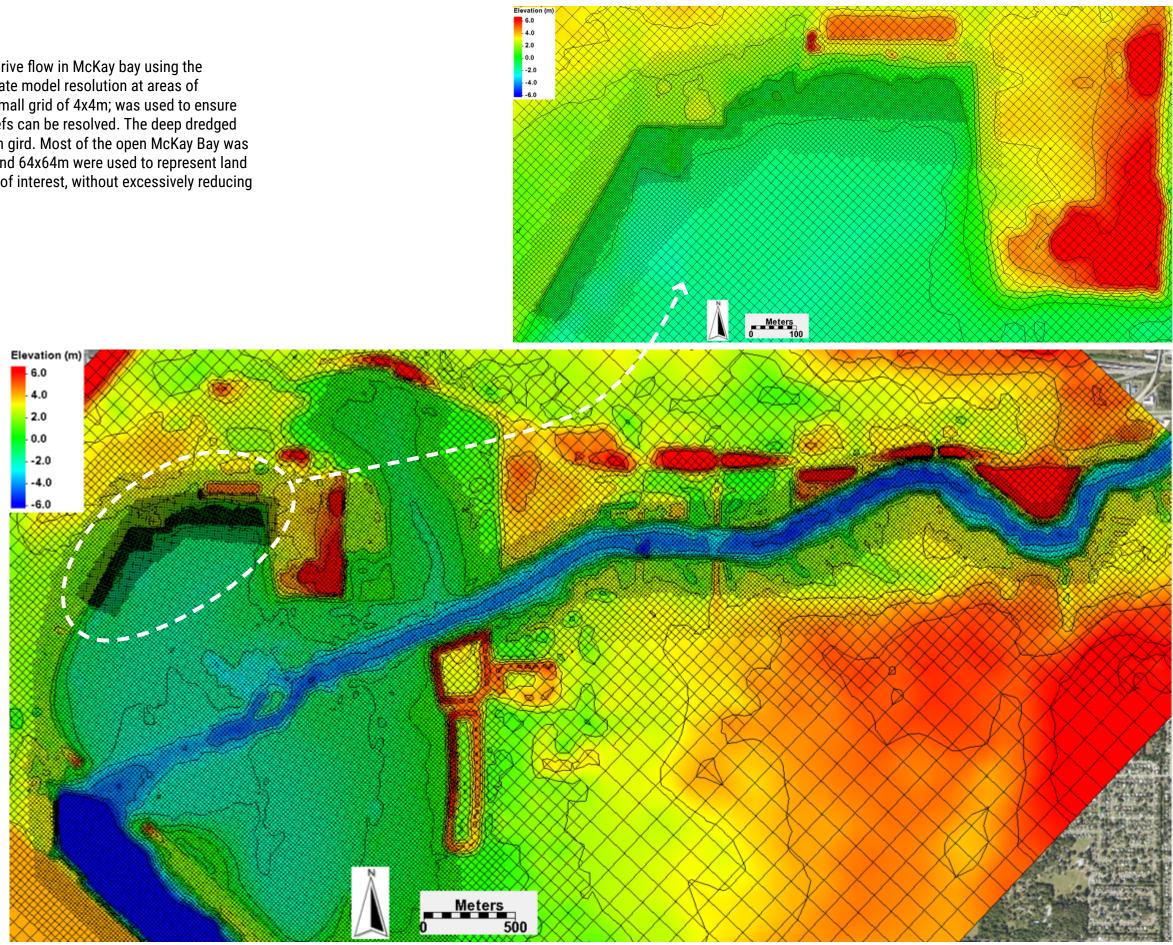
Grid for the Numerical Model

A telescoping grid was constructed to compute the tidal drive flow in McKay bay using the USACE's CMS Model. The telescoping grid ensures adequate model resolution at areas of interest. Along the Palmetto Beach coast (white oval), a small grid of 4x4m; was used to ensure potential proposed features such as artificial or oyster reefs can be resolved. The deep dredged channel and the nearshore area were represented by 8x8m gird. Most of the open McKay Bay was represented by 16x16m grid. Large grid cells of 32x32m and 64x64m were used to represent land area. This telescoping grid allows fine resolution at areas of interest, without excessively reducing computation speed

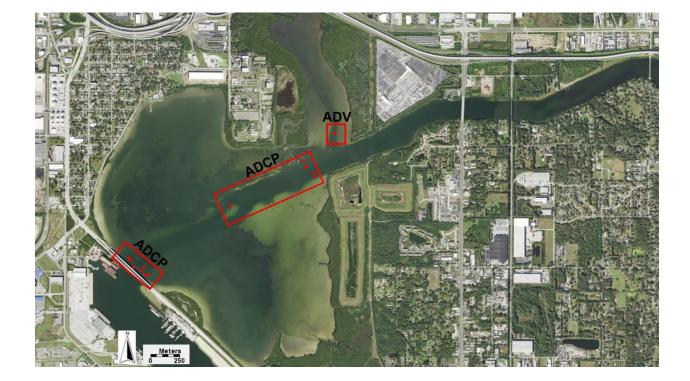
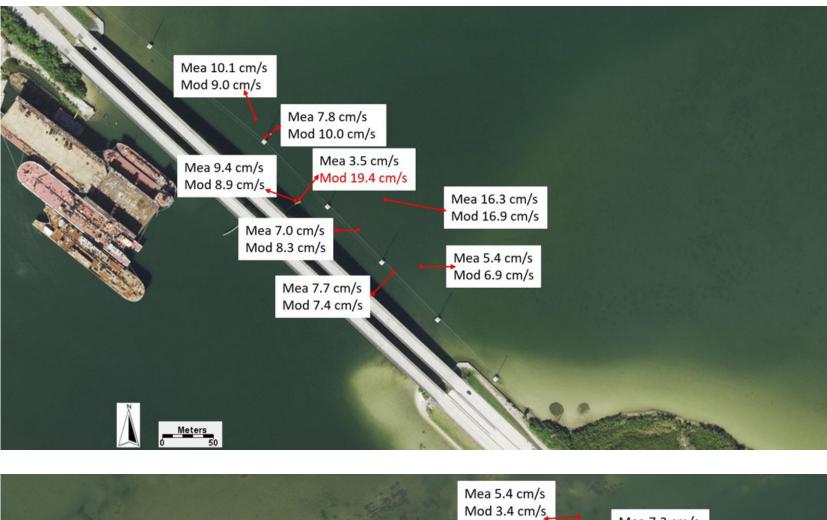
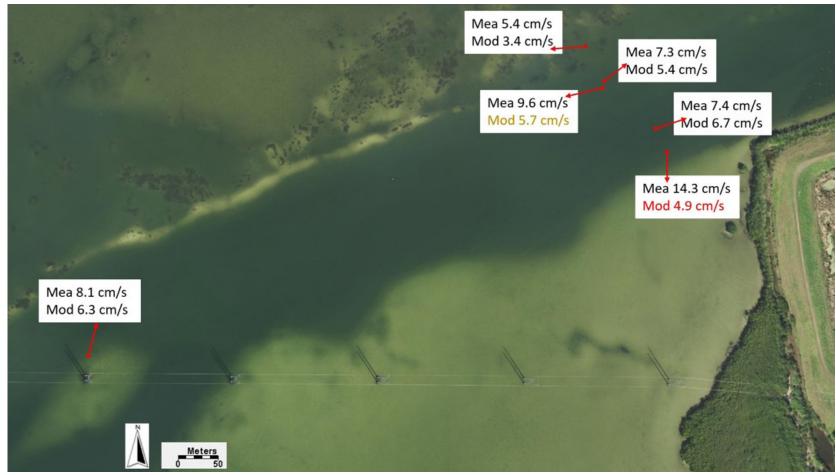
The numerical model constructed during this study was calibrated and verified with in situ field measurements of water-level fluctuations and current velocities. Temporal and spatial variations of water-level and flow were measured. A 23-day measurement was conducted at one location (labeled as ADV in the following figure). Flow measurements at various locations in the bay were conducted during one flooding tide and one ebbing tide (labeled as ADCP in the following figure). The model calibration was conducted using the 23-day measurement. The model verification was conducted using the ADCP measurements at various locations.

The numerical model was driven by measured tides at the NOAA East Bay tide station. As expected, the computed water level matched the modeled water level at the ADV site very well (Figure 1).

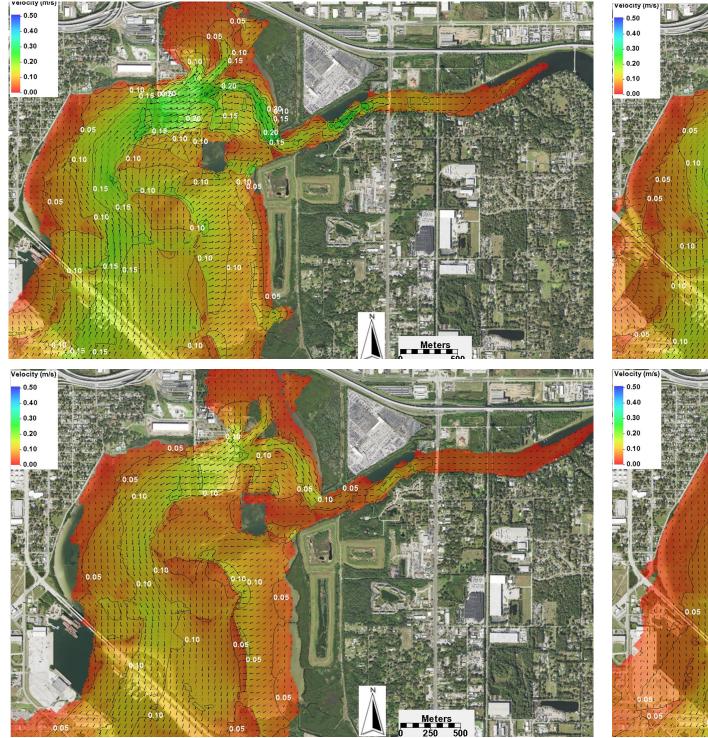
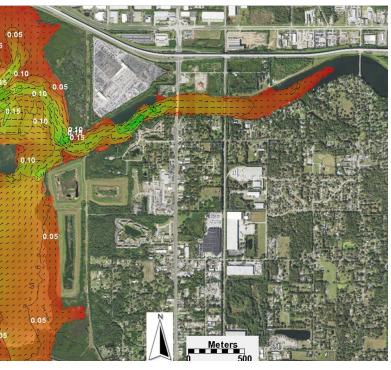
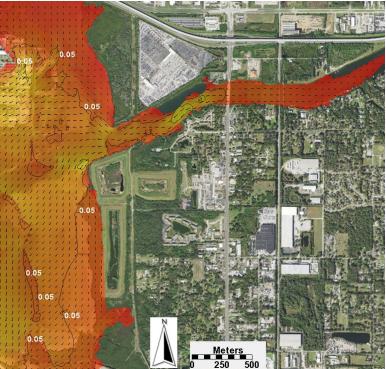
Modeling Results: Pre-engineering natural conditions – Benchmark Case

Examples of computed flow field under pre-engineering natural conditions, created based on the 1885 bathymetry map. The modeled flow fields are plotted over 2021 aerial photo. The top panels illustrate two examples of peak flooding flow driven by a rising tide, one at a lower tidal water level (left panel) and one at a higher tidal water level (right panel). The lower panels show two examples of peak ebbing flow driven by a falling tide. The naturally occurring bayhead delta and the associated shallow water, partially intertidal, at the mouth of the Six-Mile River guided the flood flow northward along the Palmetto Beach coast. At a lower tidal water level at the beginning of the rising tide (top left panel), the depth-averaged flow, as computed by the CMS-Flow, is stronger than at a higher tidal-water level near the end of the rising tide (top right panel). Similar to the spatial and temporal patterns of flooding flow, the ebb current also flows along the Palmetto Beach coast, and stronger at a lower water level near the end of the ebbing tide (bottom left panel) while weaker at a higher water level at the beginning of the ebbing tide (bottom right panel). The modeling results under the pre-engineering natural conditions indicate that the shallow delta at the mouth of the Six-Mile River, which was completely removed by the dredging operations, had a substantial control on the circulation pattern within McKay Bay, particularly in directing the flow along the Palmetto Beach coast. In the other words, the stagnant tidal flow along the Palmetto Beach coast can be attributable to the dredging of the shallow delta at the mouth of Six-Mile River and subsequent land fill along the northern shoreline.

The top two panels illustrate two examples of computed flooding tidal flow at different tidal stages: left panel illustrates the flow field at a lower tide; right panel illustrates the flow field at a higher tide.

The bottom two panels illustrate two examples of computed ebbing tidal flow at different tidal stages: left panel illustrates the flow field at a lower tide; right panel illustrates the flow field at a higher tide.

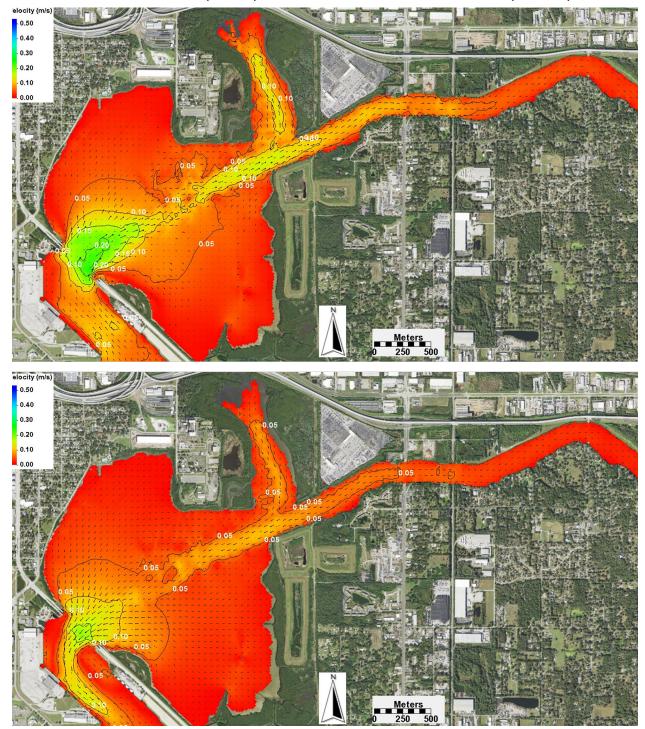
Peak tidal flow velocities (above), and minimal ebb flow velocities (bottom)

Examples of computed flow field under existing conditions driven by tide only, based on the detailed bathymetry survey conducted by this study, are shown here. The top panels illustrate two examples of peak flooding flow driven by a rising tide, one at a lower tidal water level (left panel) and one at a higher tidal water level (right panel). The lower panels show two examples of peak ebbing flow driven by a falling tide (lower panels). Compared to the natural conditions, discussed above, the overall magnitude of tidal-driven flow is significantly lower, particularly along the Palmetto Beach coast. Under existing conditions, the tidal flow is concentrated in the dredged channel through the middle of the bay, while the flow in the rest of the bay is quite weak for both flooding and ebbing tides. Since the dredged channel is quite overwhelming for a shallow bay, of nearly 5 m deep and 200 m wide, the tidal flow through the channel is also weak although concentrated. In summary, the overall weak tidal circulation within in McKay Bay can be attributed to the artificial deep and wide dredged channel, in addition to the landfill along the northern coast. It is worth pointing out an interesting feature at a wetland restoration project just to the east of the McKay Bay Nature Park & Trail. The restored tidal circulation.

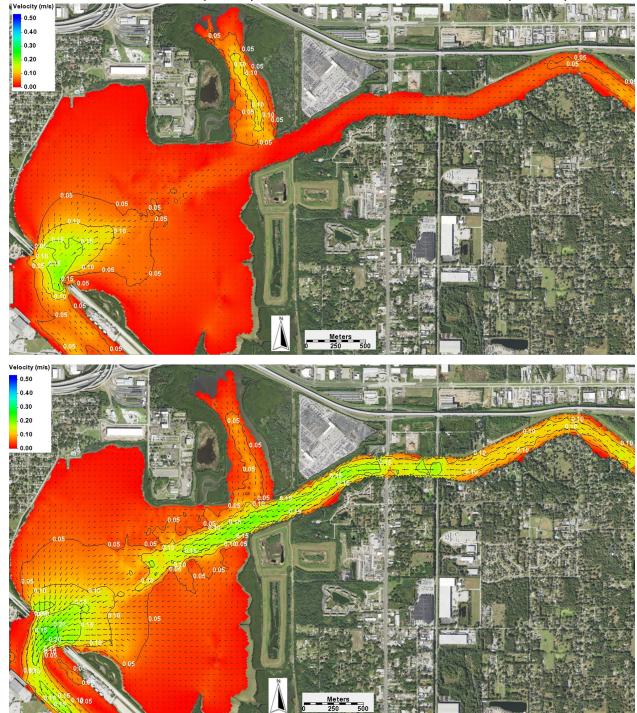
Peak tidal flow velocities (above), and minimal ebb flow velocities (bottom)

Examples of computed flow field under existing conditions driven by both tide and discharge from the Bypass Canal are shown here. Given the Bypass Canal is designed prevent flooding in the downtown area during heavy rainfall conditions, a rather large discharge of 50 m3/s was applied in this simulation to examine the contribution of flood water to the McKay Bay circulation. The top panels illustrate two examples of peak flooding flow driven by a rising tide, one at a lower tidal water level (left panel) and one at a higher tidal water level (right panel). The lower panels show two examples of peak ebbing flow driven by a falling tide (lower panels). Compared to the tide only case discussed above, the large discharge from the Bypass Canal suppressed the flood flow, while enhanced the ebb flow. Since the dredged Bypass Canal is deep (~ 5m) and wide (~200 m), even the large 50 m3/s discharge is not able to generate strong enough flow to flush the soft mud at the bottom of the dredged channel, as documented by the sediment sampling, throughout the entire McKay Bay. It is worth noting that the very large 50 m3/s discharge occurs very rarely. Overall, the discharge from the Bypass Canal has minor influence on the circulation pattern within McKay Bay. Compared to the influences of the dredge and fill operations, the flow-pattern modification by the discharge from the Bypass Canal is not significant.

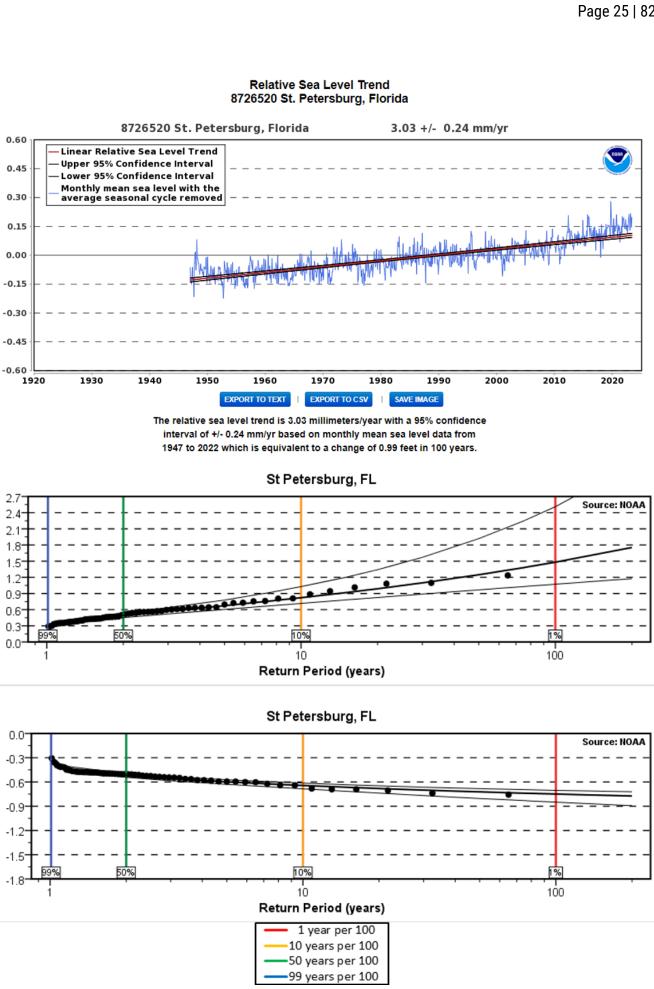
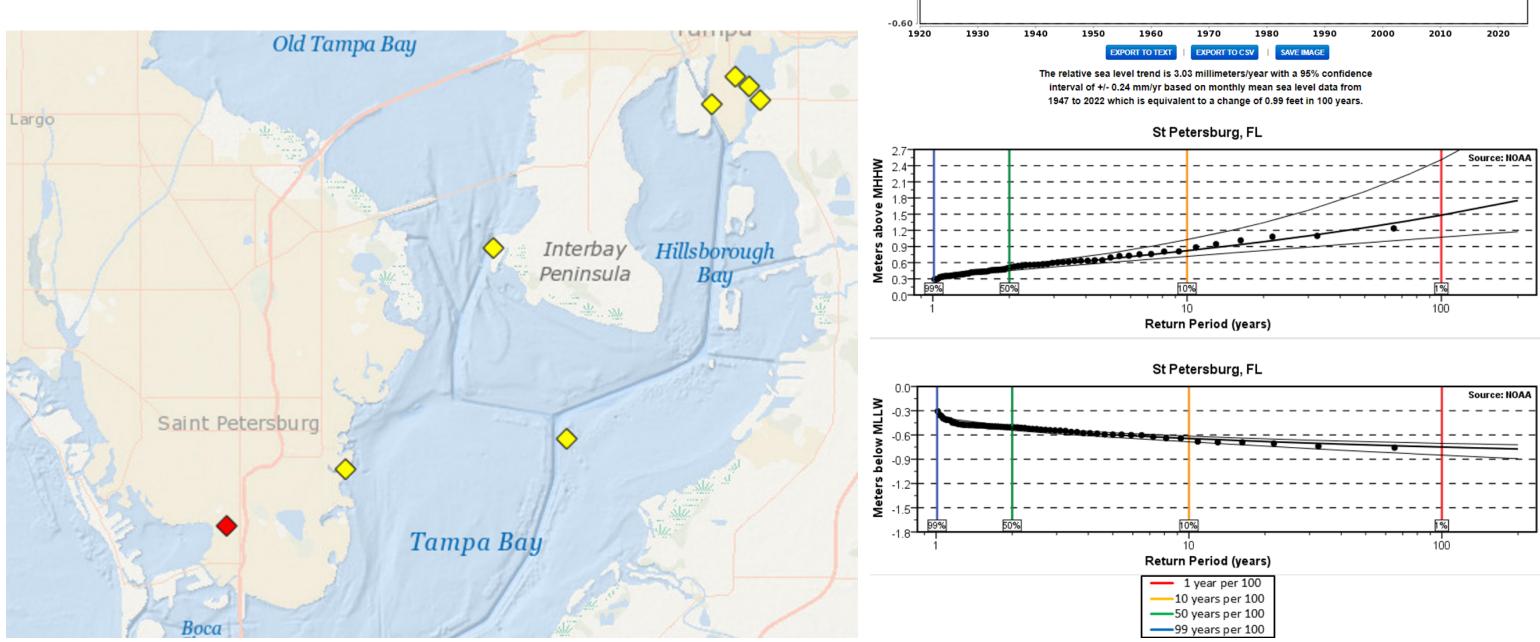
The water level is well measured with several long-term NOAA tide stations at the greater study area, including Station SAPF1 - 8726520 - St. Petersburg, Tampa Bay (1947-2023), Station OPTF1 - 8726607 - Old Port Tampa (2006-2023), Station TPAF1 - 8726694 - TPA Cruise Terminal 2, Tampa (2008-2023), Station TSHF1 - 8726679 - East Bay Causeway (2009-2023). The SAPF1 - 8726520 Station has the longest record of 76 years and is used here for storm surge and sea-level rise analysis. The measured sea-level rise is shown in the following figure. Extreme water-level analysis results are also provided at this Station and is shown in the following. Furthermore, the relative sea-level change (RSLC) projections used by USACE at St. Petersburg Florida is used and illustrated below. These RSLC projections were used by the USACE in the 2023 Tampa Harbor Navigation Improvement Study. The USACE design horizons of 25 year (2056) and 50 year (2081) are included in this figure.

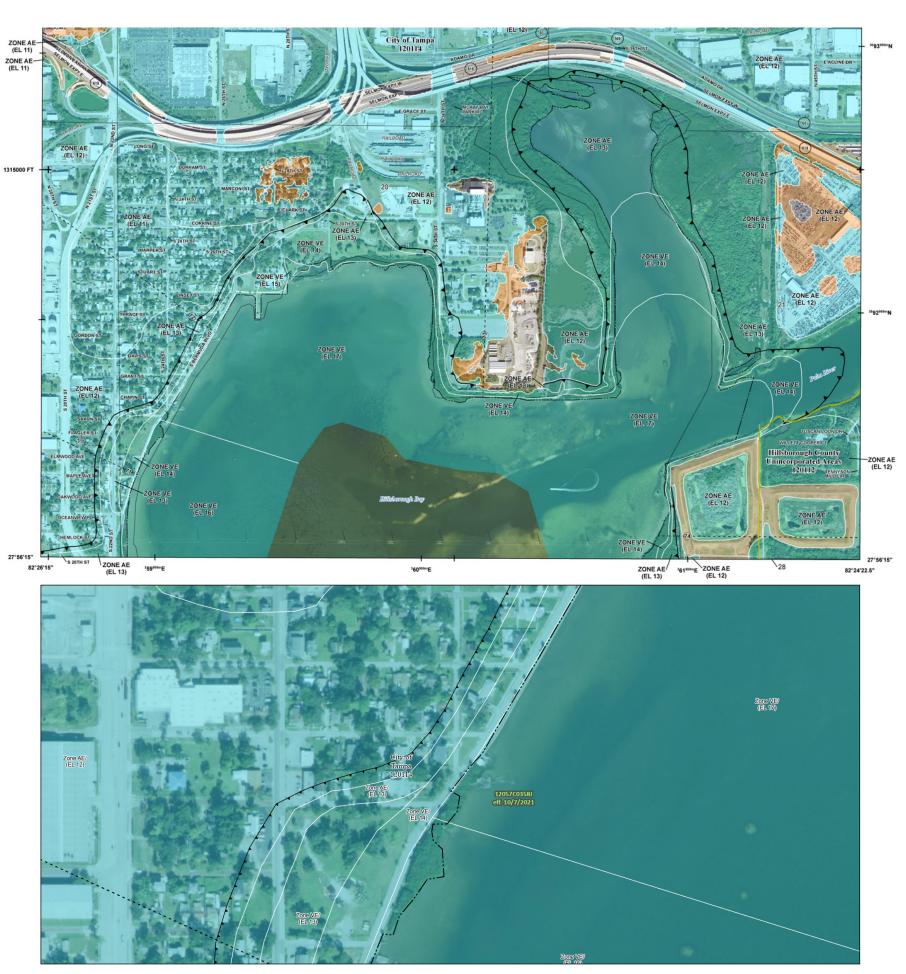
Flood Zones

The Palmetto Beach community is almost entirely within FEMA's 100-year (1%) flood zone. This is shown by FEMA's recently updated (2021) Flood Insurance Rate Maps (FIRMs). Near the shoreline of Bermuda Boulevard many properties are within the VE zone, with base flood elevations from 13 to 17 feet NAVD88. An additional area, containing about 1 block from the shoreline, is within the Limit of Moderate Wave Action (LIMWA) area - denoted by a line with triangle flags. Inland from that, the community is within the AE zone with base flood elevations between 11 and 13 NAVD88.

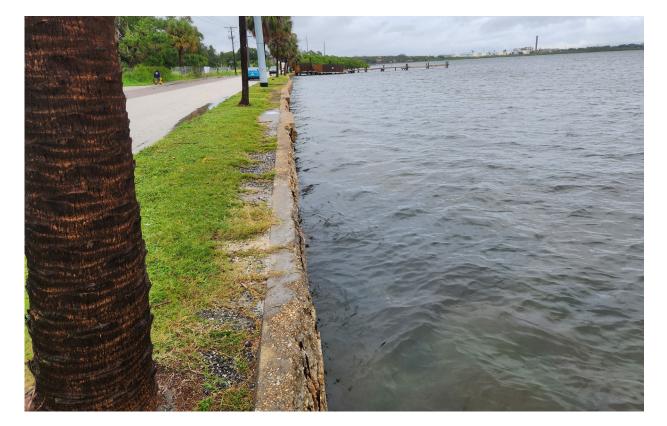
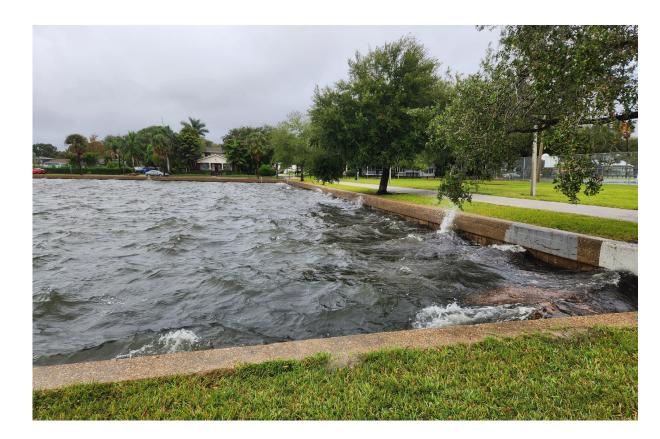
Observed Storm Surge - During Tropical Storm Nicole

Tropical Storm Nicole in 2022 passed the study area distally providing an opportunity to observe the impact of a modest storm and its surge to the project area. As measured by the NOAA East Bay tide gauge, Tropical Storm Nicole generated a 1.64 ft storm surge above a spring high tide. Based on the NOAA extreme water-level estimate at the SAPF1 – 8726520, St. Petersburg Station, the 1.64 ft (0.5 m) storm surge generated by Tropical Storm Nicole corresponds to a 2-year return period storm. The seawall along Bermuda Boulevard and Desoto Park have, based on review of surveys, a minimum elevation of 4.3' NAVD. The highest recorded surge with Tropical Storm Nicole was 2.78' NAVD88. Based on the extreme water level estimated above, the 4.3 ft (NAVD 88) seawall would be overtopped by:

- 1) a 50-year storm surge without incorporating SLR, or
- 2) A 10-year storm surge superimposed on the mid SLR curve by 2050, or
- 3) A 10-year storm surge superimposed on the low SLR curve by 2100

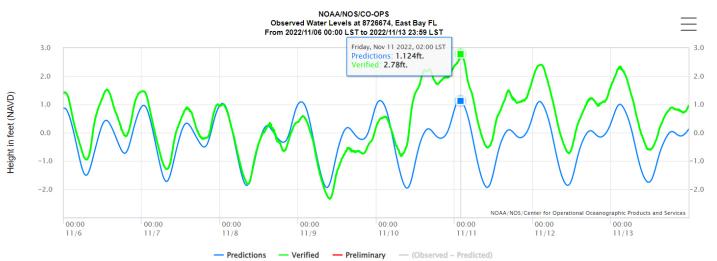
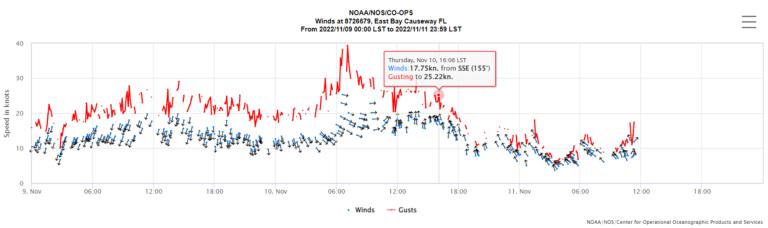
Source: NOAA Tide Gauge for East Bay, Tampa

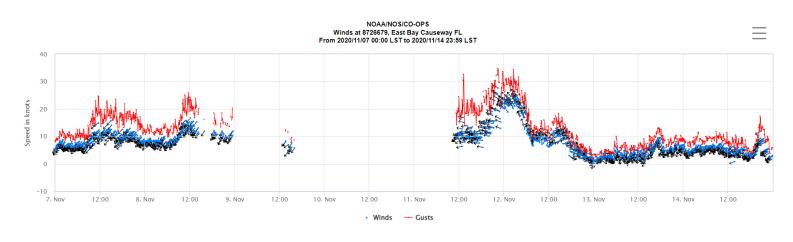
Tropical Storm Eta represented a recent high water event. Different from Tropical Storm Nicole, Eta passed the study area much closer on November 10-11, in 2020. The NOAA East Bay tide gauge near Palmetto Beach recorded a high water level of 4.7' NAVD88, which overtopped some sections of the seawall. Tropical Storm Eta generated a storm surge of nearly 4.2 ft. However, the storm surge was superimposed on a neap tide, resulting in a total water level of 4.7 ft. Based on the NOAA extreme water-level estimate at the SAPF1 – 8726520, St. Petersburg Station, the 4.2 ft (1.3 m) storm surge generated by Tropical Storm Eta corresponds to a slightly over 50-year return period storm. Fortunately, it occurred during a neap tide. If it had occurred during a spring high tide, much more flooding would have occurred. In summary, the observations during the passages of Tropical Storms Nicole and Eta confirmed the extreme water-level estimates by NOAA. Given the NOAA estimates were based on measurements, this agreement is expected.

Source: NOAA Tide Gauge for East Bay, Tampa

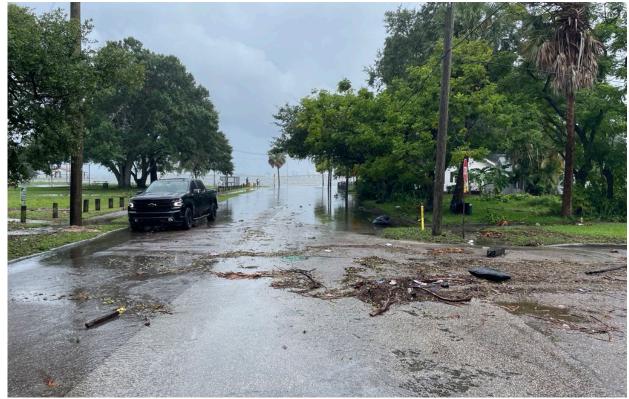
Rack line shown in post-surge condition from Hurricane Idalia, August 30, 2023 - at elevation 5.42 NAVD.

Hurricane Idalia did not bring extreme weather to McKay Bay and Palmetto Beach, but it did bring a significant amount of elevated tide -- up to elevation 5.42' NAVD88 according to the NOAA East Bay tide gauge. Hurricane Idalia passed approximately 100 miles to the west on August 30, 2023, making landfall in the Florida Panhandle. The apex of surge occured during a low tide period, buffering the overall impacts, but was during a high tide associated with 1-year stillwater elevations. NOAA tide predictions estimated 1.66' for the higher high tide that day, which is close to the 2.0' 1-year stillwater elevation. Water levels overtopped the Desoto Park and Bermuda Boulevard seawall and filled the community with water, 2-3' in some areas.

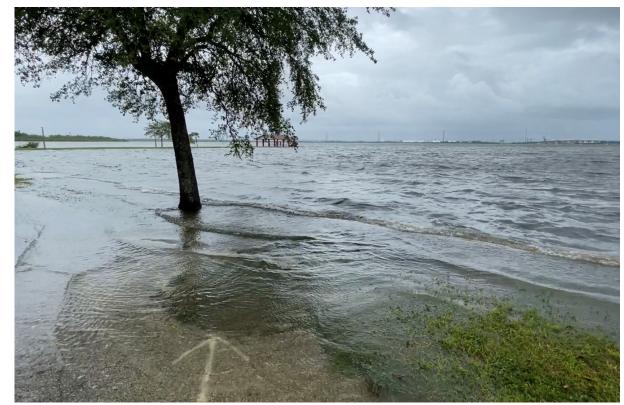
Seawall overtopping from Hurricane Idalia.

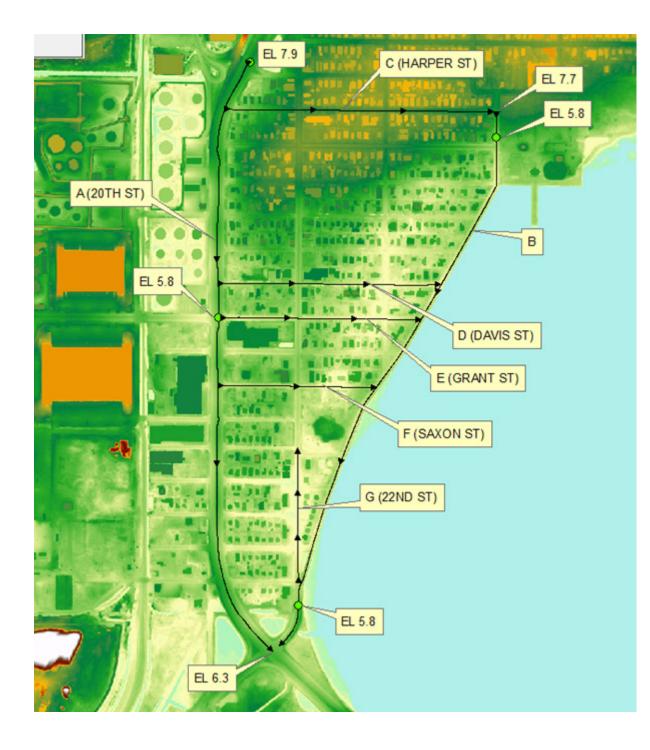
Seawall Survey

Seawall and topographic elevations were studied for the Palmetto Beach Community to evaluate protection levels from coastal surge. The lowest elevations along 20th Street, a major boundary for the area, is at approximately 5.8' NAVD88, with a consistent low elevation of about 6'. On the eastern edge, at Bermuda Boulevard, the roadway elevations are mostly between 3.3' and 5' NAVD88. Top of seawall elevations included in a PD development application survey near Saxon Street were between 4.3' and 4.8' NAVD. Because the streets are connected to the Bay through the numerous stormwater drains, seawater can be backed up onto the streets through the drains. In other words, the seawater does not need to overtop the seawall to induce flooding in areas that are lower than the seawall.

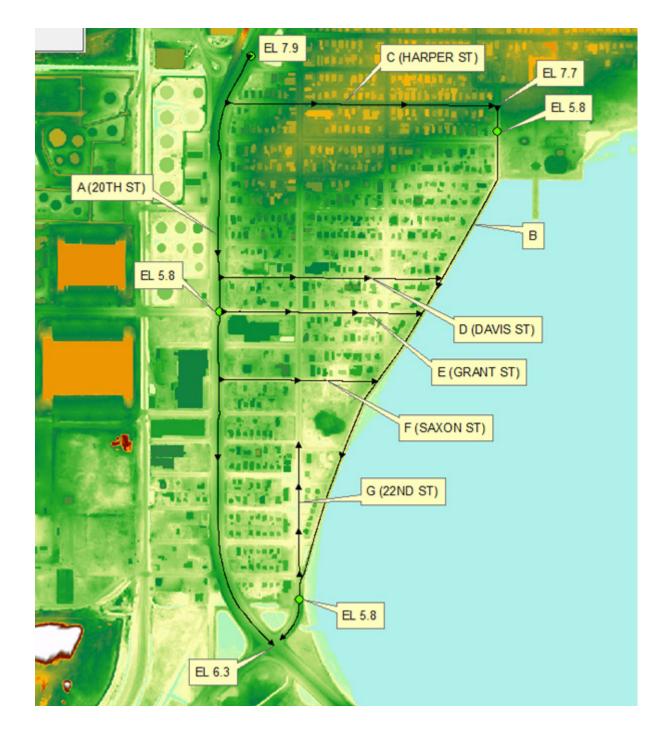
The low elevation stretches of Streets D, E, F, and G, at slightly above 3 ft NAVD88, are vulnerable to flooding from coastal waters that go inland through the system and exit through storm drains. Based on the analysis above, a 10-year return period storm without incorporating projected sea-level rise would flood these low sections of the road.

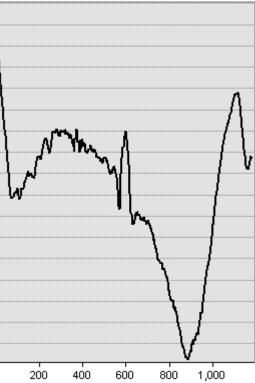
McKay Bay Facility

The land associated with the McKay Bay Waste Transfer Center and Waste to Energy facilities were reclaimed from the dredging in the 1950s and 1960s. The restored wetland and tidal creek along Section B allowed some circulation during higher tide, based on the modeling results. Overall, the developed portion of the peninsula is much higher than the surrounding area.
