PALMETTO BEACH LIVING COASTLINE AND COMMUNITY

Project Report

CITY OF TAMPA AUGUST, 2023

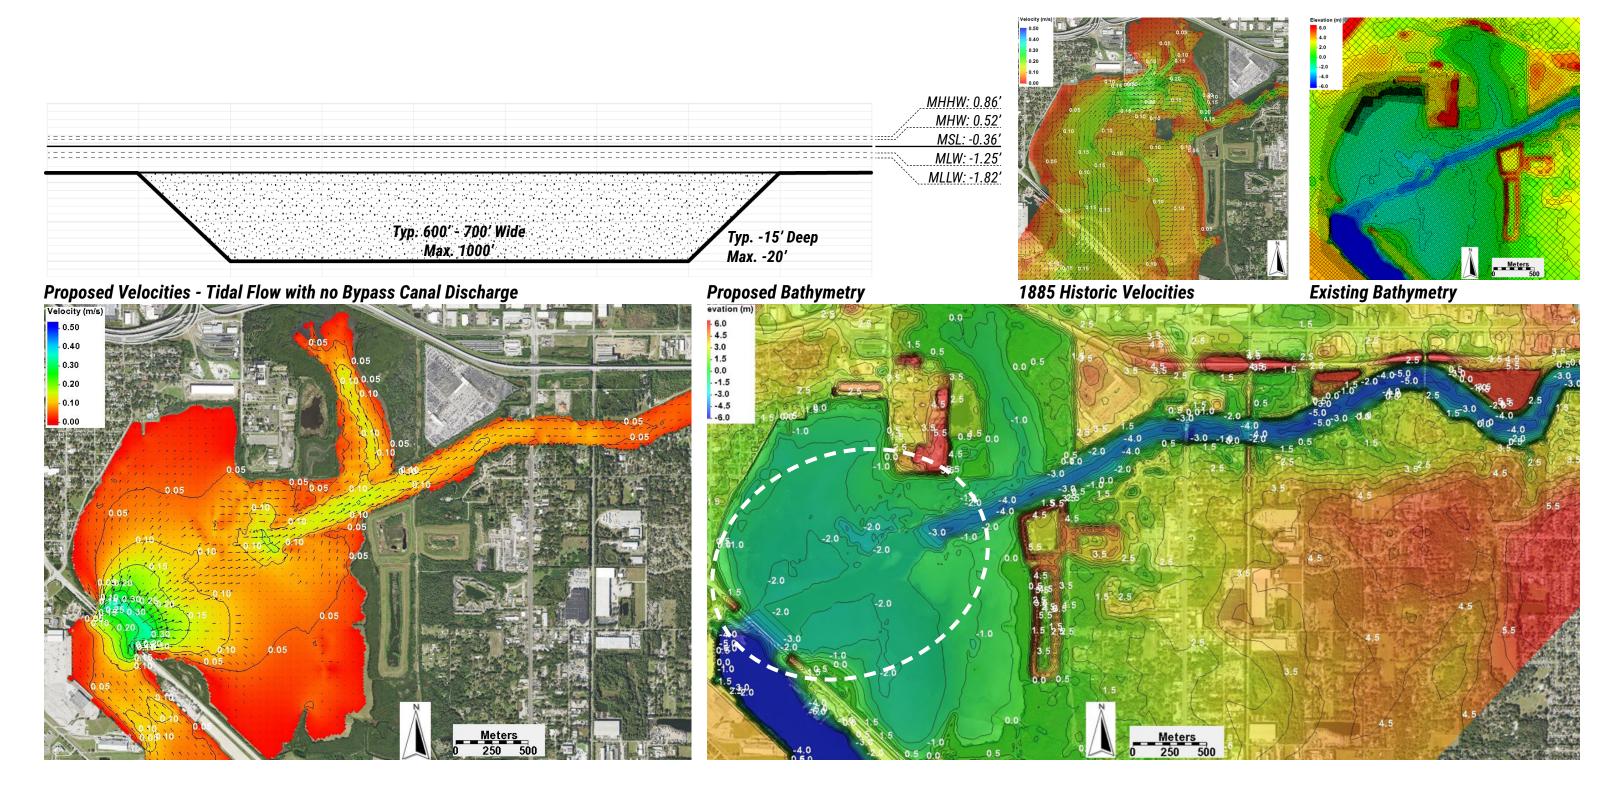
Alternative 1 (A1): Fill the Channel From 22nd Street Causeway to the Mouth of the McKay Bay Peninsula

A1 involves filling the dredge channel from the 22nd Street causeway to the McKay Bay peninsula. A1 would fill a portion of the deeply dredged channel and require less material as compared to A2. Results from the flow modeling shows that filling this portion of the channel will also disperse the flow through a large portion of the bay and therefore improve circulation, instead of concentrating flow within a deep channel. Model results indicated that discharge from the Bypass Canal would not induce additional flooding due to the filling of the deep channel.

A total of 390,000 cubic yards of sediment will be needed for A1, much less than A2. Based on the cost estimate provided by Hershorin et al. (2019), i.e., a dredging cost at \$18/cy plus turbidity containment at \$128/lin ft of dredged hole perimeter, the total cost is estimated at \$7,920,000. Since this is proposed as a potential beneficial use of the material from Port of Tampa expansion, the dredging cost would be part of the channel improvement, with the additional turbidity containment cost of \$896,000.

Alternative 1 (A1): Fill the channel from the 22nd Street Causeway to the McKay Bay peninsula. This alternative would require less sediment than A2, Discharge from the Bypass Canal was simulated to ensure there is no resultant flooding due to the partial elimination of the deep channel.

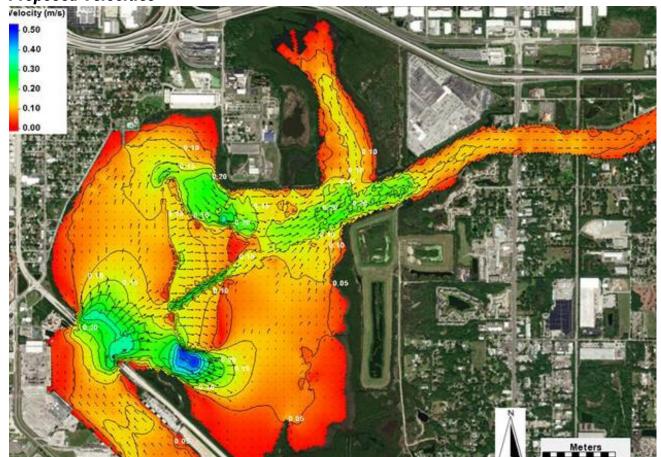
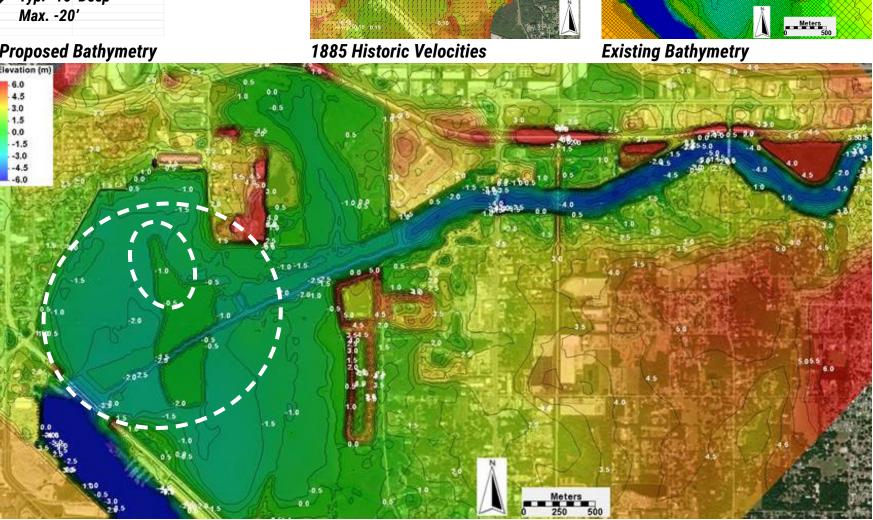
Proposed Bathymetry

Alternative 5D: Emulate Historic Delta with Strategic Fill (Version 1)

A5D includes a 3-m channel through the entire bay for Harbor pilot vessel. In addition, it includes a strategically designed shoal emulating the historical delta, although at a different location, with a spur. The modeling results show that the shoal and spur would guide the tidal flow along the Palmetto Beach coast. Overall, A5D would restore the flow pattern comparable to the pre-engineering natural pattern.

MHHW: 0.86'

A5D is recommended as an optimal option to improve the circulation within McKay Bay.

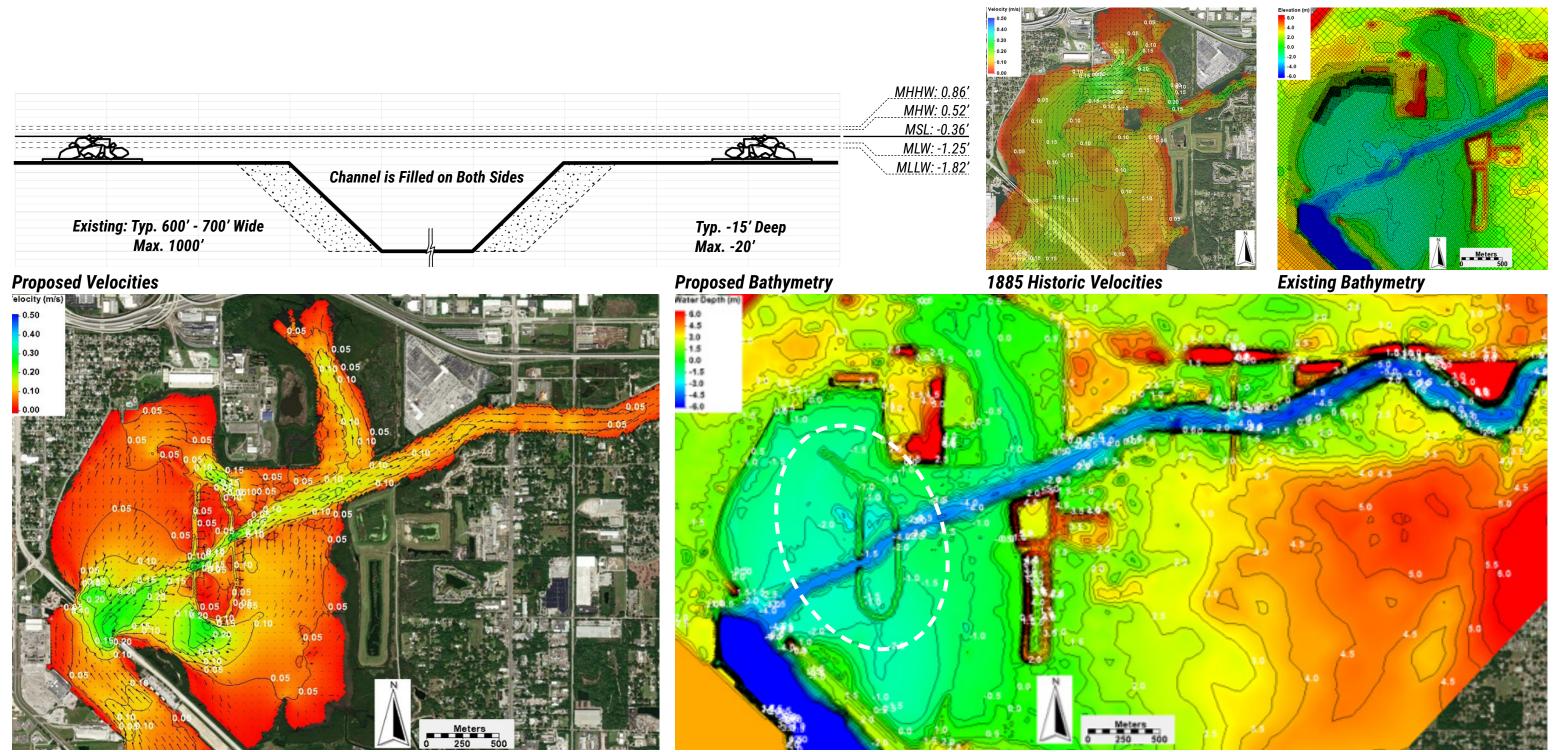
Different from Alternative 5, A6C does not involve significant fill. The deep channel through the Bay would remain at existing condition. A strategically designed oyster reef system with a spur would be constructed. The oyster reef system outlines the shallow shoal for the Alternative 5 cases. The main difference is that no fill is designed for the channel or the shallow shoal. The function of the shallow shoal is achieved, at least partially, by the oyster reef. The modeling results indicate that the oyster reef system would improve the flow along the Palmetto Beach coast. However, the velocity magnitude is about 50% of the scenario with the channel and shoal filled. A6C includes a small fill to narrow the deep channel at the intersections.

A total of 35,000 cubic meters, or 45,000 cubic yards, of materials and oyster reef are needed for the construction of A6C. Based on the cost estimate provided by Hershorin et al. (2019), i.e., a dredging cost at \$18/cy plus turbidity containment at \$128/lin ft of dredged hole perimeter, the cost is estimated at \$2,129,604.00. The cost of the oyster reef is at \$1,300/lin ft, putting the reef cost at \$13,260,000, making the overall project cost estimate \$15,389,604.00.

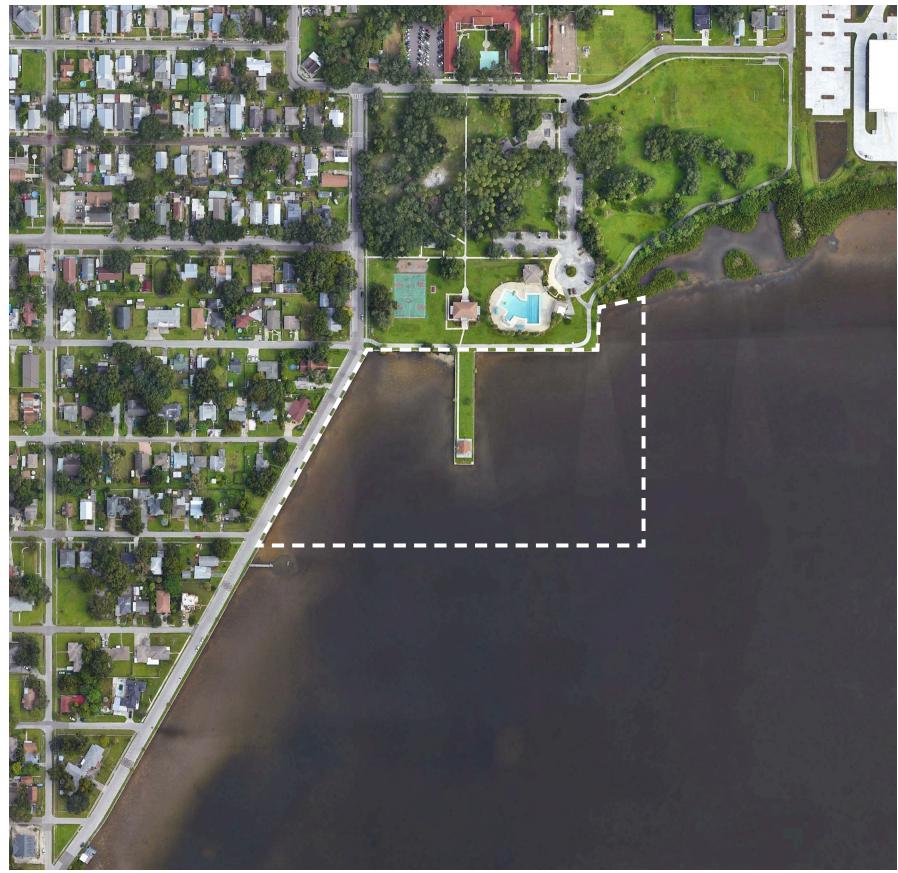
Concept: Rip Rap Coastline Option 1

In this design, the original seawall was removed along the Desoto Park property (only), and was replaced by a new undulating rip-rap slope. In the northwest corner of the bay an oyster sill was placed in front of marsh and mangrove plantings. This isolated planting would not obscure views to the end of the pier, where there has historically been illegal activity and vagrancy. To improve this condition, the end of pier shade structure has been removed. The seawall around the pier was also removed, as well as the fill material, and was replaced with a boardwalk to increase water circulation.

A new floating kayak launch was added on the east side of the park, which can be accessed from the parking lot.

Replacement of the seawall with rip rap causes changes in water levels (up to 10 cm or about 4 inches) in the area immediately adjacent to the riprap barrier. Increases in flooding are clear and expected where the pier is to be removed and the fringe of the park where the riprap would be placed.

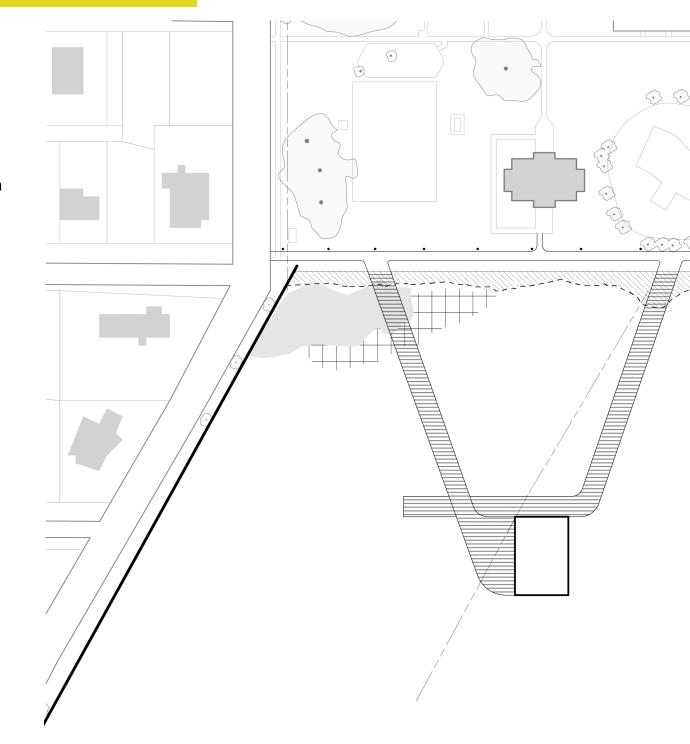
This design is the same as Option 1, except the boardwalk is altered to increase pedestrian circulation opportunities, addressing safety issues for the community. Two boardwalks are proposed, to create a loop connection. They meet at the existing pier island. The existing approach is removed.

This design option would cause very similar outputs as Option 1.

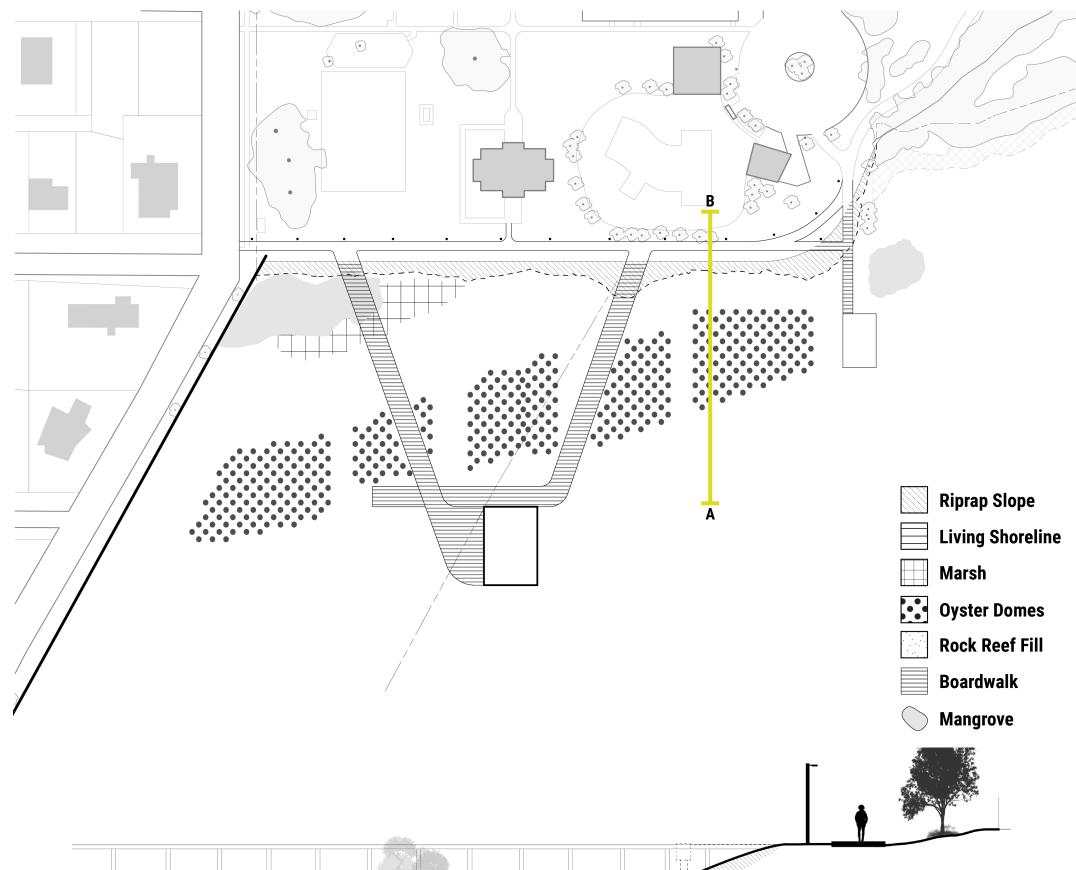
This design builds upon Options 1 and 2 and adds concrete oyster dome or living reef structures to promote oyster growth and soil stabilization.

Again, this design option would cause very similar outputs as Option 1.

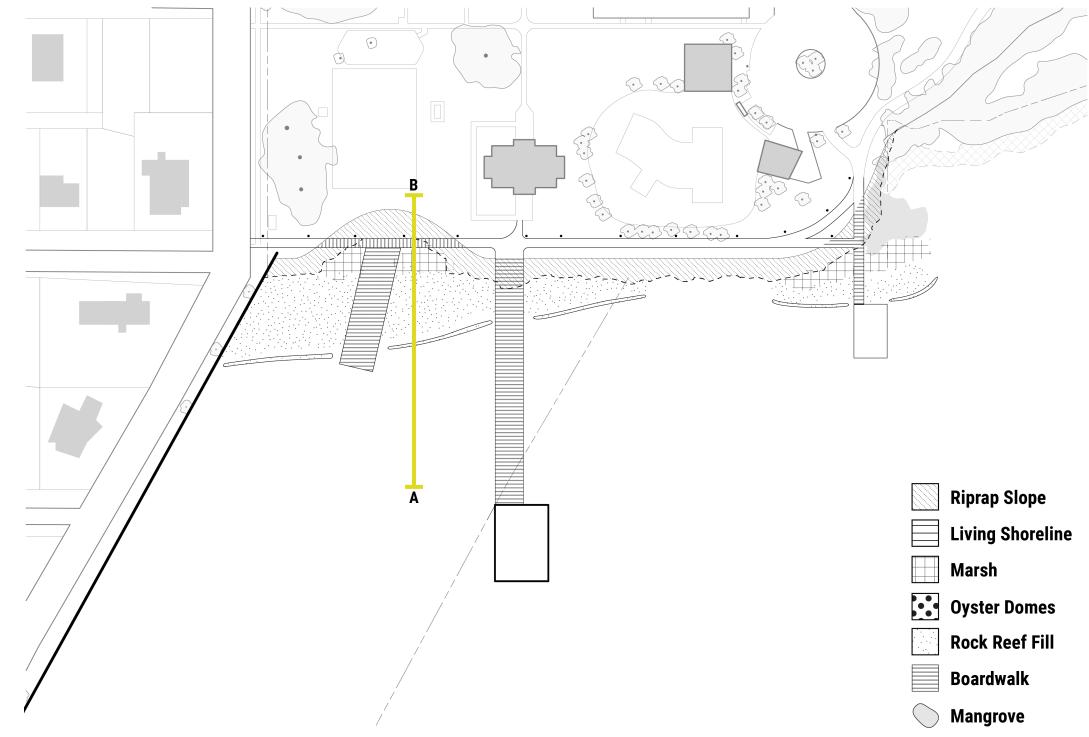
This design brings a section from the existing coastline inland to create a marsh and mangrove walk-through space with boardwalk. An additional pier is proposed that would allow more access to the water and visibility to the end of the existing pier. The approach to the existing pier is removed and replaced with a boardwalk deck. Areas of hardened substrate and oyster-growing materials are also built up by the coast, contained by a line of oyster bags.

This design option would cause similar outputs as Option 1, but with an increase in flooding inland nearby the area where the new pier is proposed.

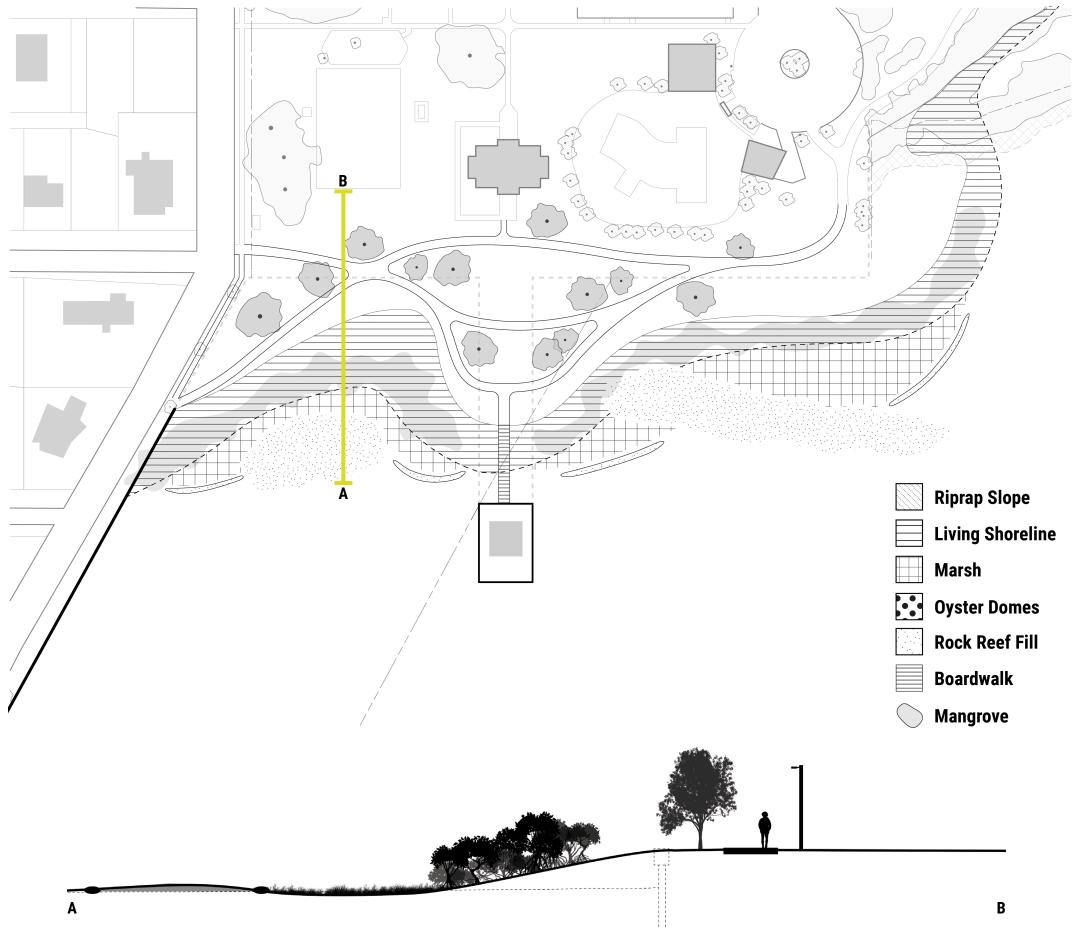
This design uses a significant amount of fill to create a new shoreline. The original seawall is removed and a new, gently sloped coastline is created in front, lined with marsh, mangrove, and oysters. The original pier is removed and replaced with a short boardwalk. The design creates dramatic change to the coastline with opportunities for native and wetland vegetation to fill in. Shortening the approach to the end of the pier increases safety.

This design option would cause widespread decrease in flooding (up to 4 inches) in the DeSoto Park waterfront.

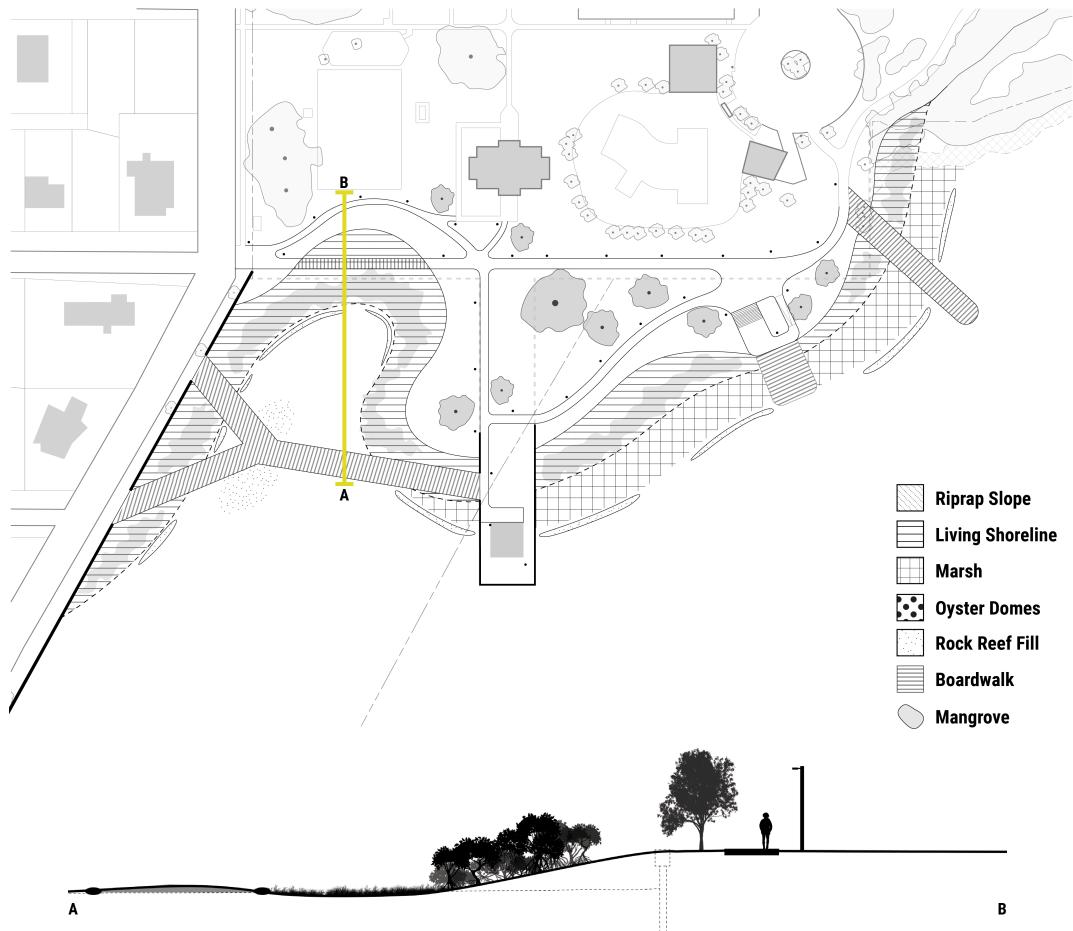
This design is similar to Option 5, but it includes the addition of new piers and outlook locations. The pier seawall is replaced with a new seawall, and a small, paved plaza area is added near the pool, with steps and ramp to the water's edge.

The extent of drier conditions would extend a bit offshore from Option 2, but an increase in flood depth would be expected west of the old pier.

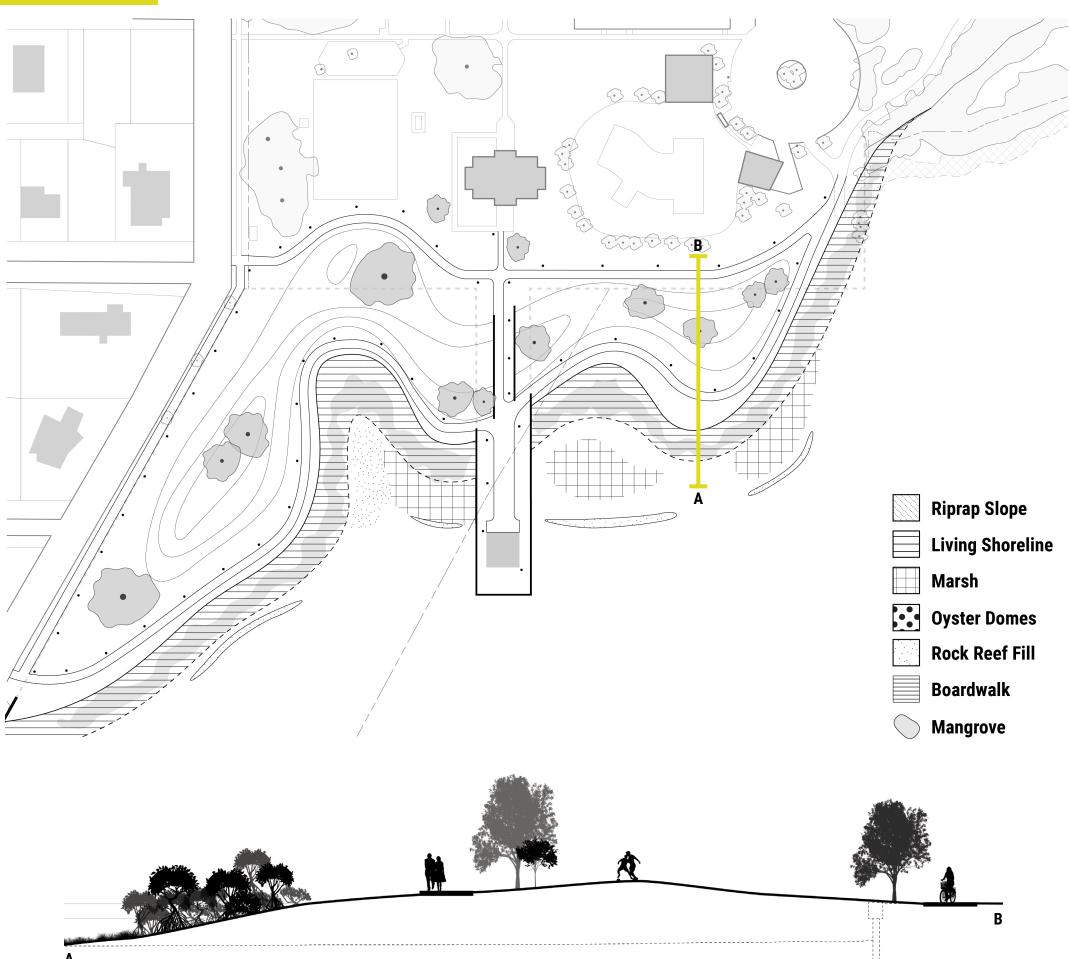
This design creates a sweeping naturalized edge. Behind it, a berm provides space for an overlook, to see above coastal mangroves, and to provide coastal protection. Walls are added to cut through the berm and create a connection to the replaced pier.

Drier conditions are expected not only offshore from the park, but also in the area around the proposed vegetated edge.

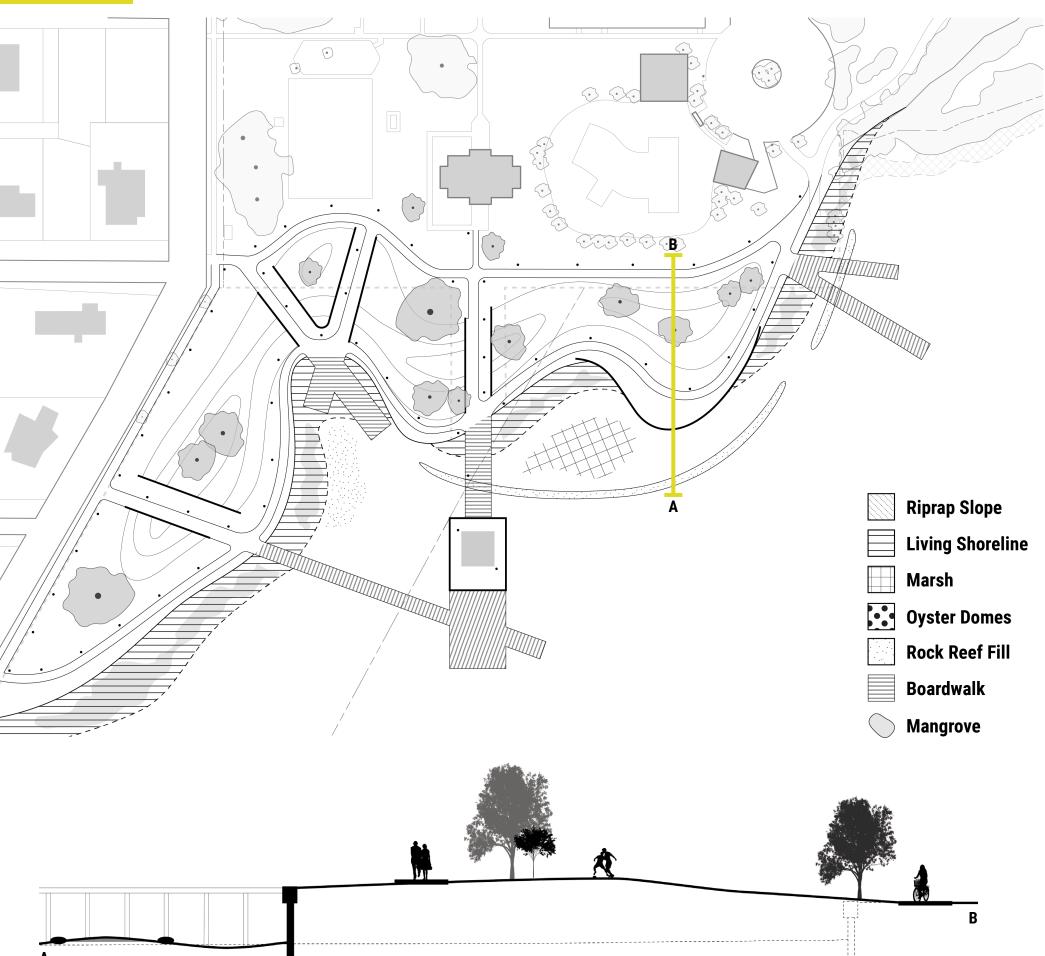
This design is similar to Option 7, with the addition of more piers. Seawalls are also added to create viewpoints and minimize mangrove growth. The existing pier is replaced by a boardwalk and an added point of access is provided from Bermuda Boulevard, where there is a higher density of residential population.

Very similar conditions to those expected for Option 7.

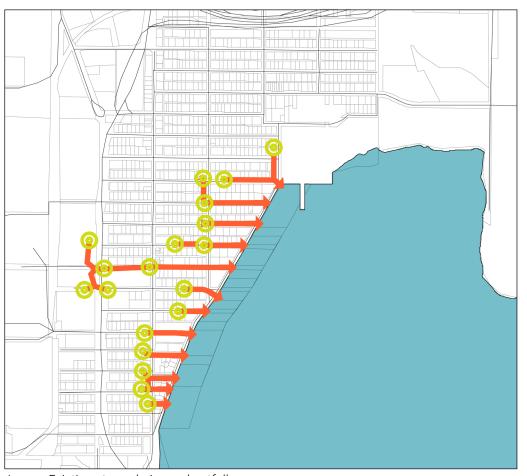
Image: Proposed storm drains and baffle boxes

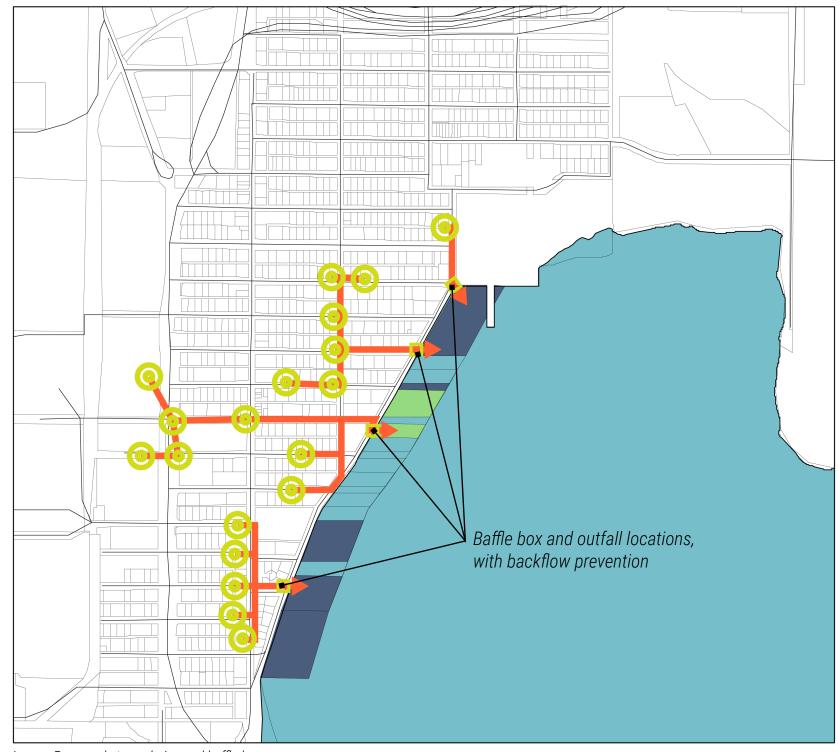
Image: Existing storm drains and outfalls

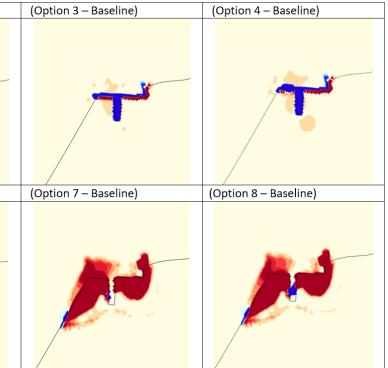
Table 9: Water depth comparison for all options.

In each design option, there is not much more than 4" of difference shown in surge elevation modeling. This is not dramatic, but could be the difference in flooding or not for low-lying houses, streets, and drainage systems.

In options one through four, additional water is shown in the area, which would be expected when removing fill and replacement with a boardwalk pier. Opposite, options five through eight show decrease in water presence because of fill replacing open water. However, options 5, 7, and 8 show additional benefits that protect the intersection of 22nd and Linsey streets at the northwest corner of McKay Bay, with option 7 providing the most protection.
